**DESIGN GUIDELINES FOR DOWNTOWN
CLARESHOLM**

THE CLARESHOLM MAIN STREET GUIDELINES

Produced by The Alberta Main Street Programme

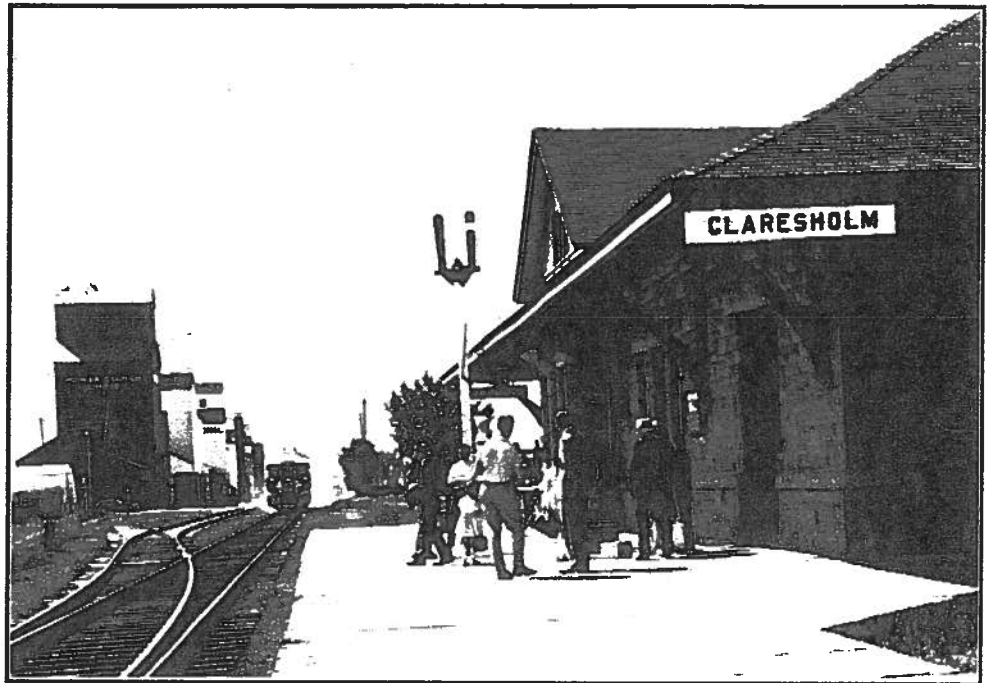
*Fig. 4
Claresholm CPR Train Station was
constructed in 1912 of sandstone
quarried from the first Calgary CPR
station*

In the traditional small prairie town manner the main street of Claresholm developed parallel to the railway. The CPR train station, an important landmark of the development era, marks the northern boundary of the historic town core and the water tower the southern boundary.

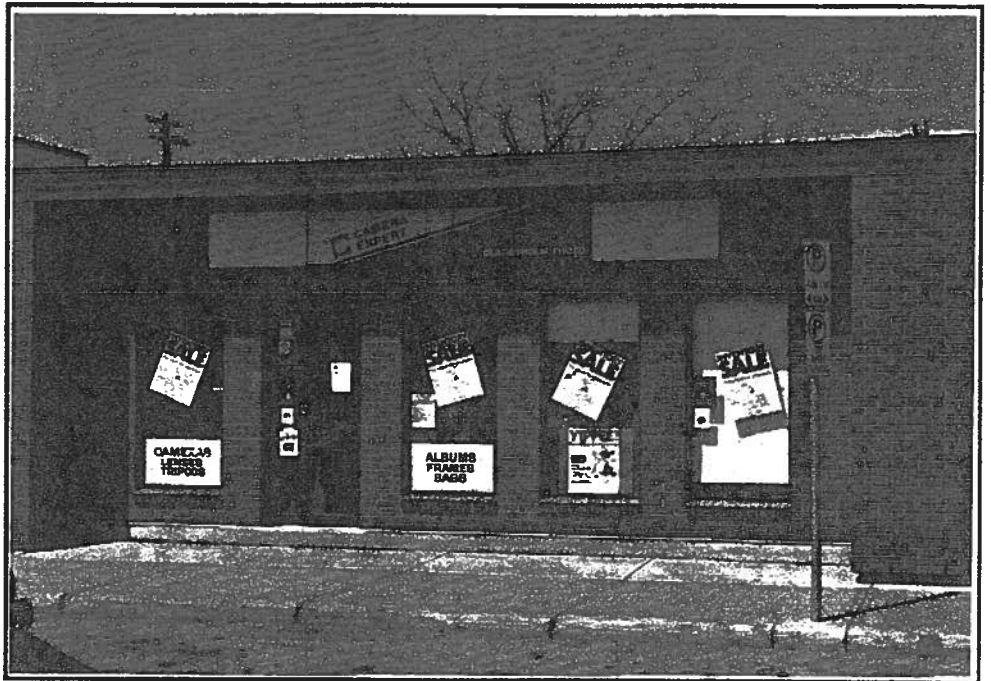
Fig. 14
Present day Claresholm Photo on 49
Avenue, Modernist style 1990

This style is characterized by the use of only a few materials like aluminium, glass and plastic. Storefronts simplified or sometimes eliminated the traditional bulkhead, transom, sign board, awning, cornice and decorated pediment in favour of few details and large sheets of plate glass from ground to ceiling recessed under a thin flat-roof overhang.

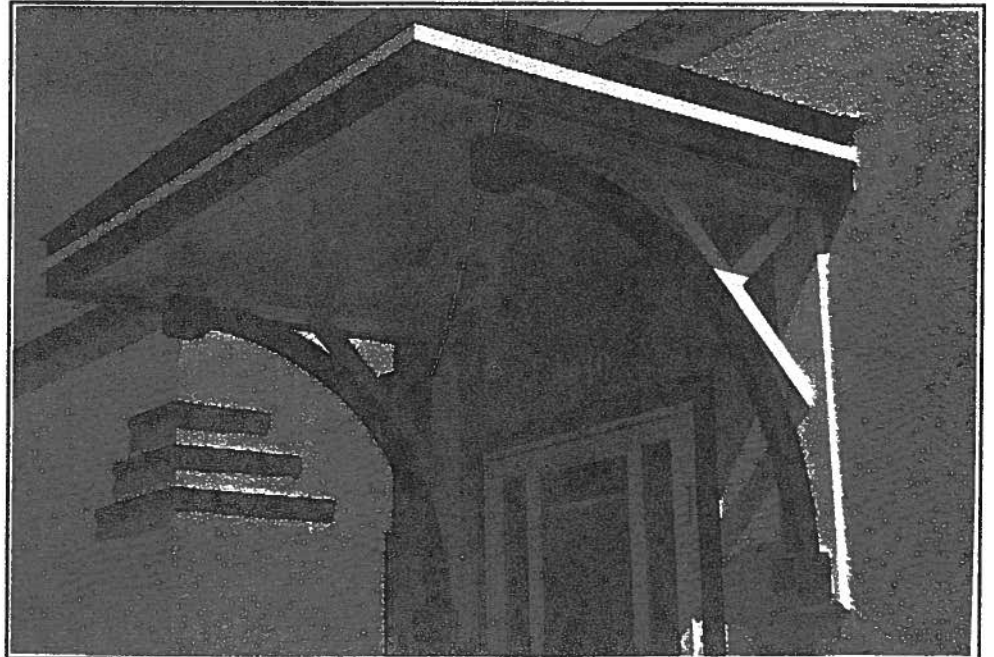
*Fig. 19
Painted wood canopy and brackets on
Dr. Carroll's residences after restora-
tion*

Painted wood, a traditional material, was used for storefronts, windows, doors and ornamentation.

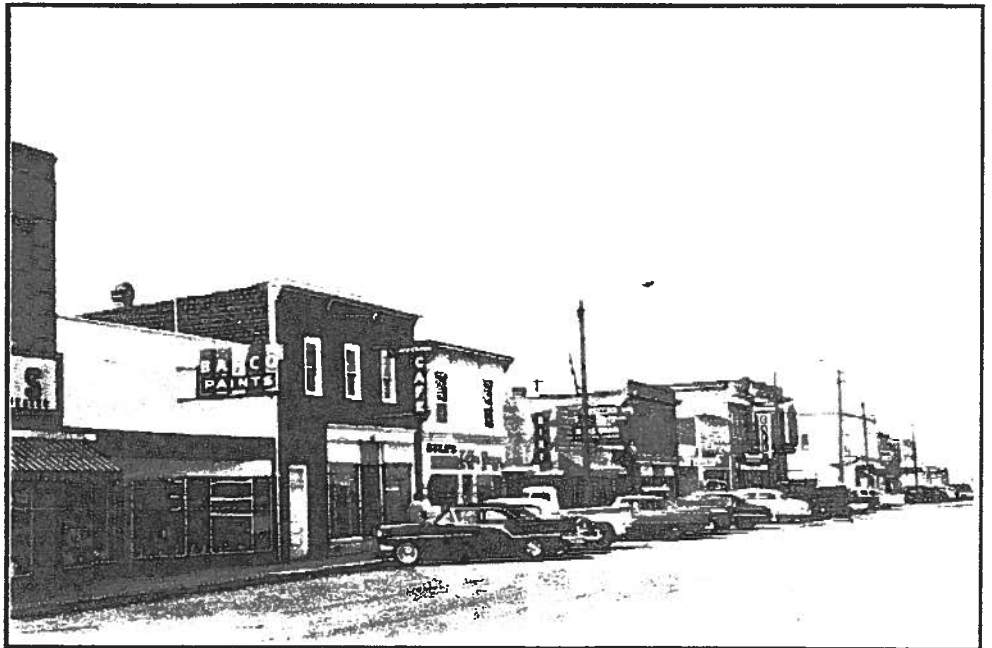
Fig. 22
Similarity of scale along the facades of
historic Railway Street [present day
Hwy 2] circa 1960

The visual character of downtown Claresholm is enhanced by similarly scaled building elements. The concern for scale was an important part of the traditional design process in terms of height and width of buildings. Storefront details from one building to the next were often similarly designed as were upper storey windows and the decorative treatments. Each building had a unique look, but retained significant harmony with its neighbours. Post World War II buildings were more likely to break the traditional patterns.

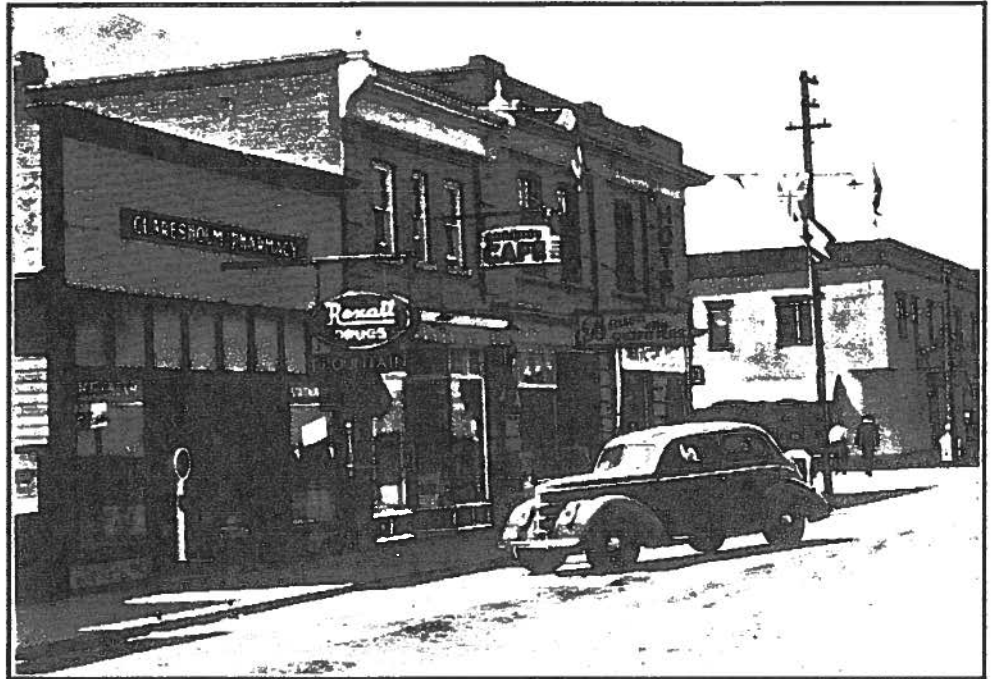
Fig. 24
Along Railway Street [present day First Street] in the 1920's

Buildings from the historic period tended to incorporate horizontal lines and patterning which helped relate one building to the next.

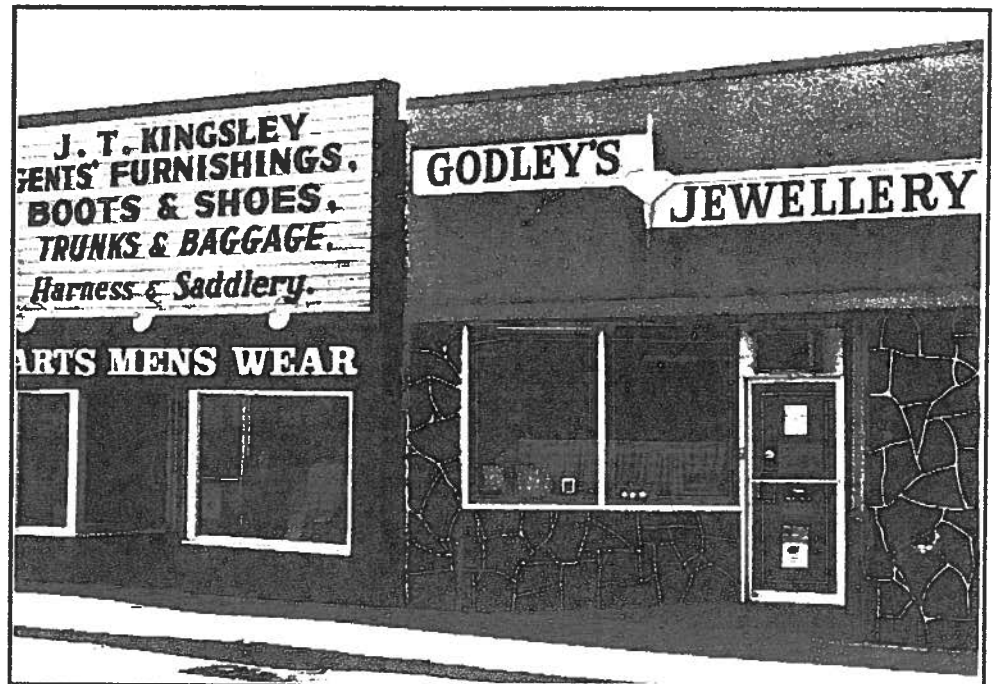
Storefronts are a primary form of merchandising. Storefront entrances, usually symmetrically located, were often deep set to provide weather protection and to increase the exposure of shoppers to the window displays. Historic storefronts were characterized by large display windows, with painted ornamental wooden bulkheads below and glass transoms above, which allowed natural light to penetrate inside the store.

Fig. 29
Present day storefronts on Hwy 2 maintain the traditional storefronts recessed entrance

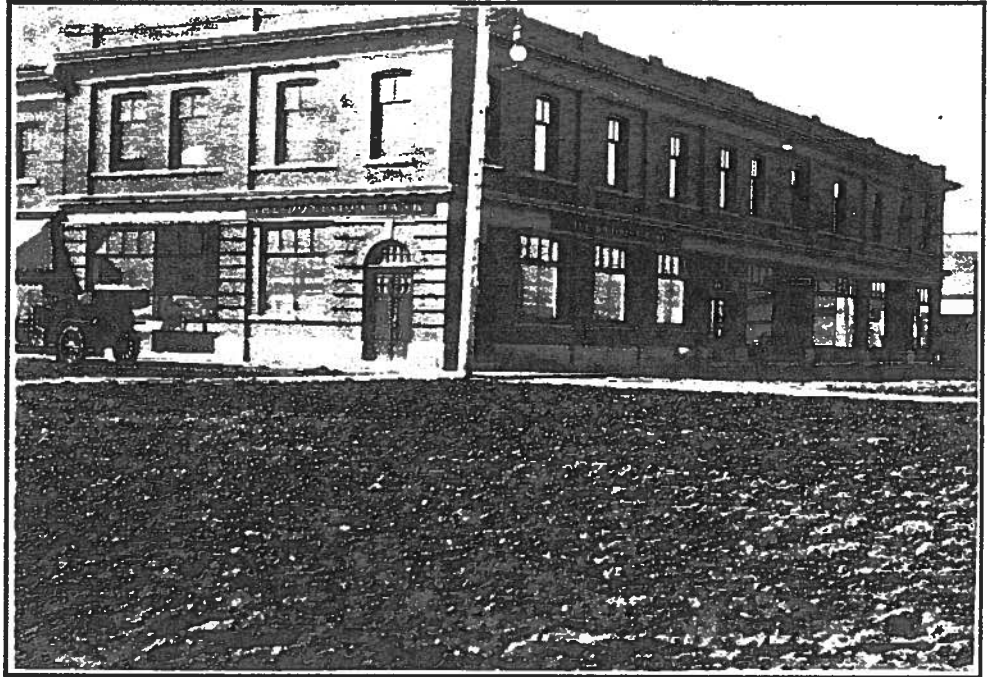
*Fig. 32
Traditional signband on the historic
Milnes Block*

Signage was usually above the storefront and below the second floor windows, where it could be easily read from the street. To enhance long-distance reading, small projecting signs were used, particularly after 1920 as automobile use increased.

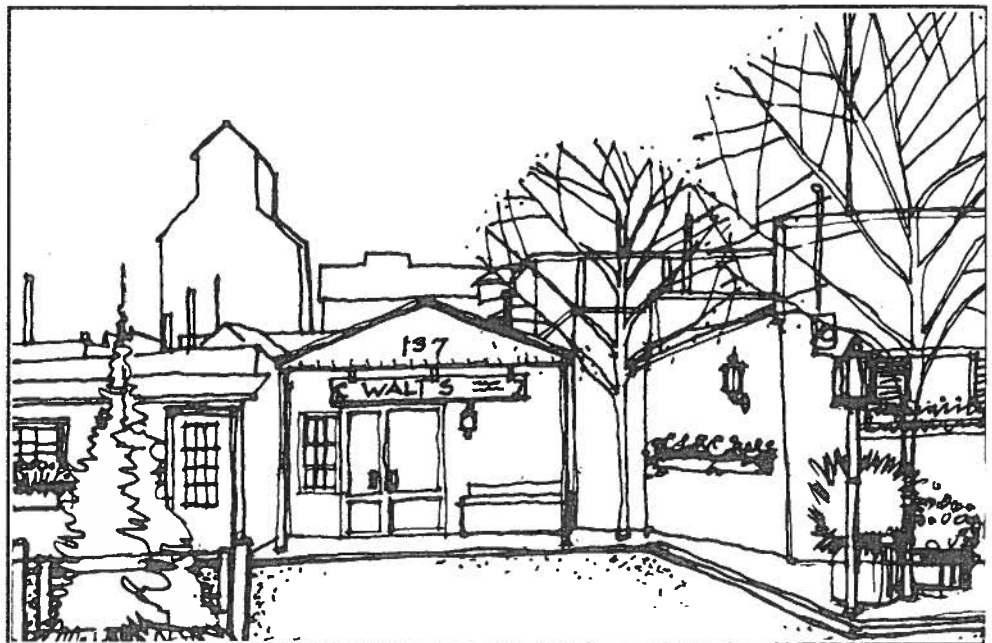
Fig. 37d
Proposed enhancement of secondary entrance

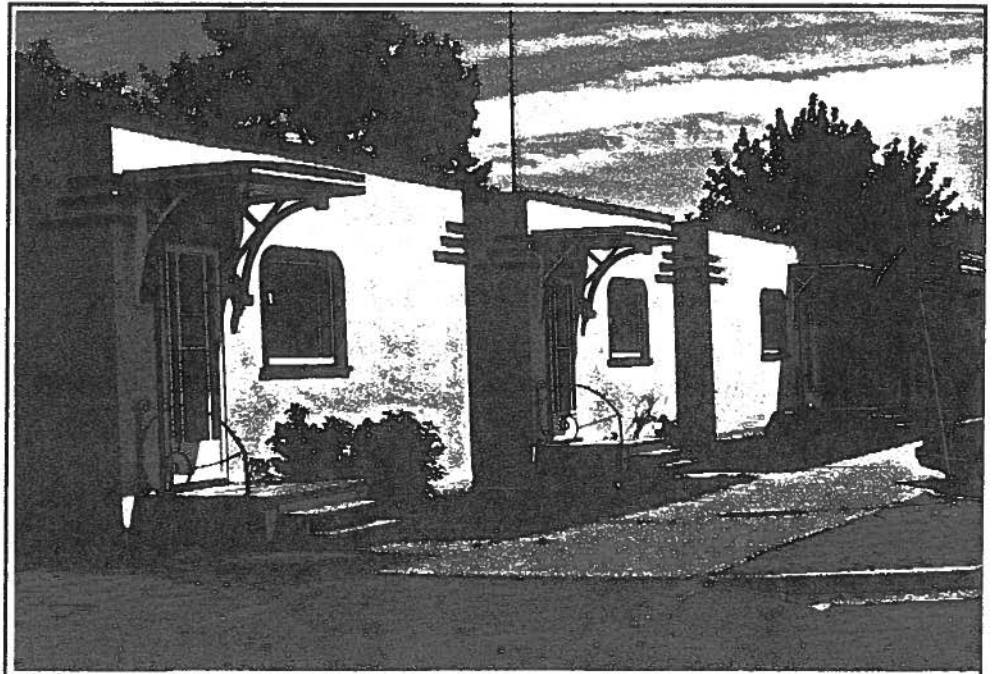
Fig. 44
Dr. Carroll's residences, 1990

Examples of minimally altered buildings are the Union Bank Building and the Dr. Carroll's residences. Photographs illustrate that the facades have not been altered over time. The original elements of the facades are in need of repair and on-going maintenance.

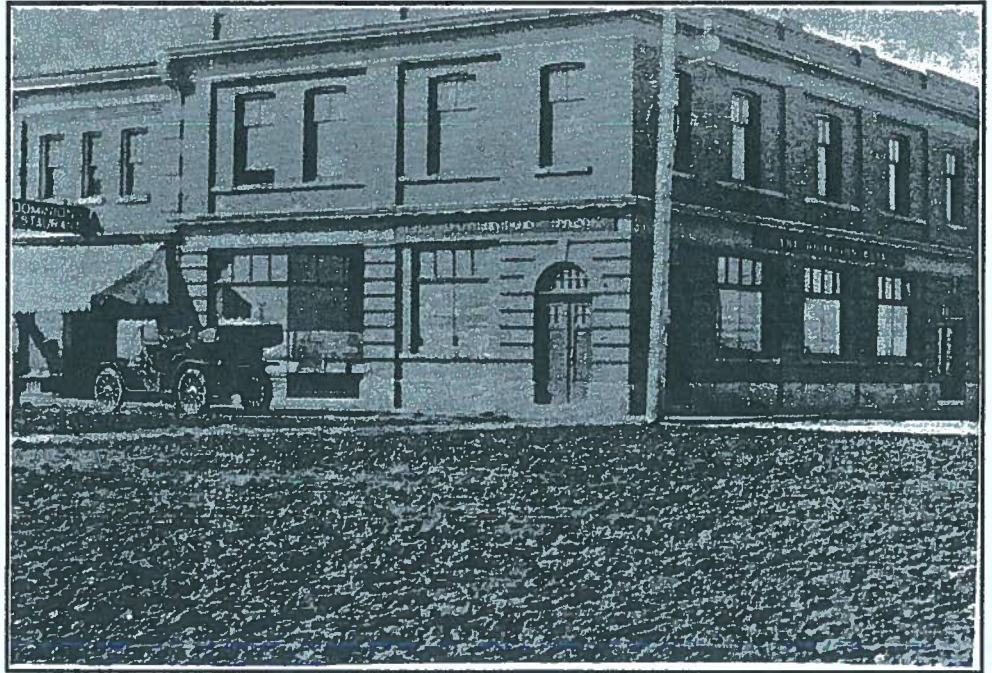
*Fig. 54
Historic Milnes Block circa 1930*

An owner may decide to replace some items on the facade of the building which have been previously removed or which have deteriorated beyond repair. Original material or photographic documentation of original condition is required prior to any replacement.

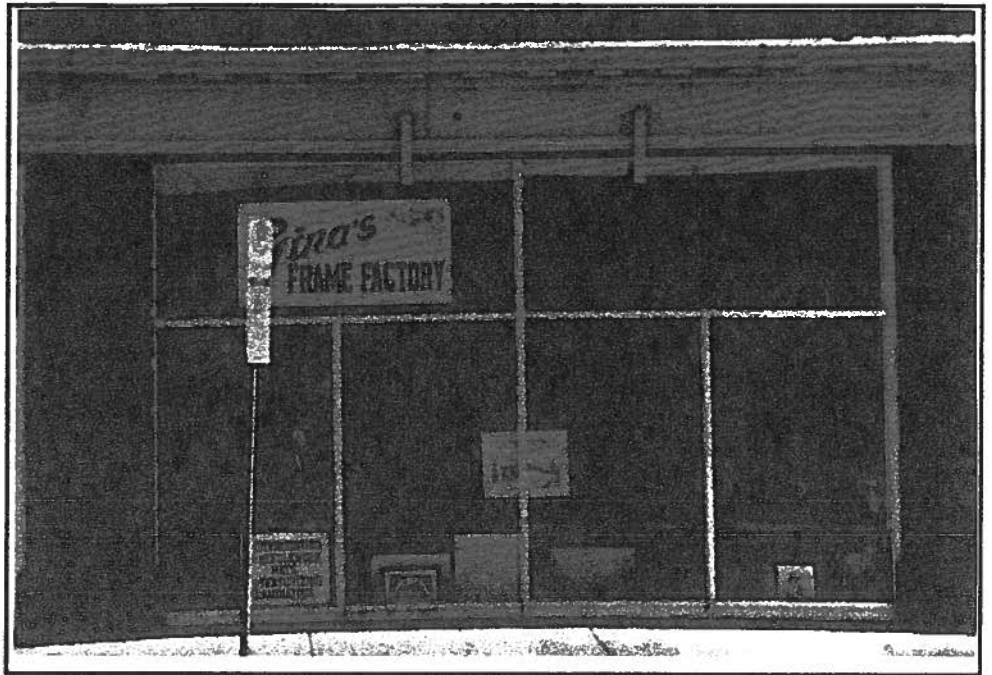
*Fig. 56
Milnes Block storefront before recon-
struction*

This approach is extensive and is to be considered only when most or all of an original building facade is missing. It requires detailed documentary information about the original facade to ensure accuracy.

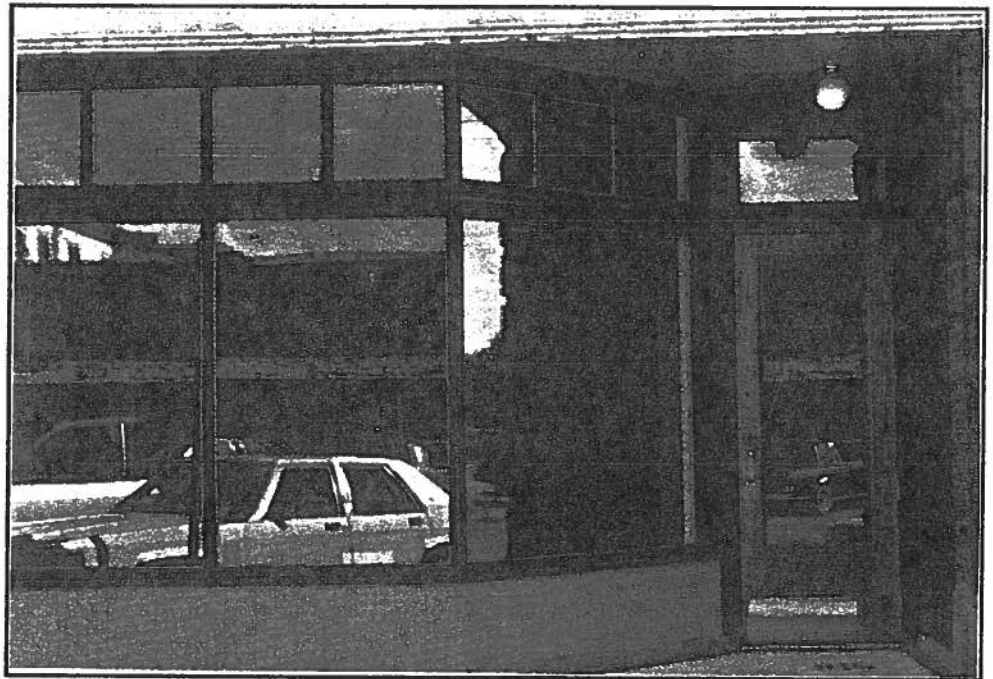
Fig. 60
The restored storefront of the Milnes Block

The storefront is the single most important element of the facade of early commercial buildings. The typical storefront prior to 1950 was composed of bulkhead panels [below the display windows], large display windows, transom windows above the display windows, a recessed entry and an entablature which capped the storefront, usually consisting of a narrow sign band and a cornice.

Preserve and maintain original storefront elements and configuration. Expose, repair and maintain original materials where possible. Replacement of missing elements is recommended where sufficient documentation exists.

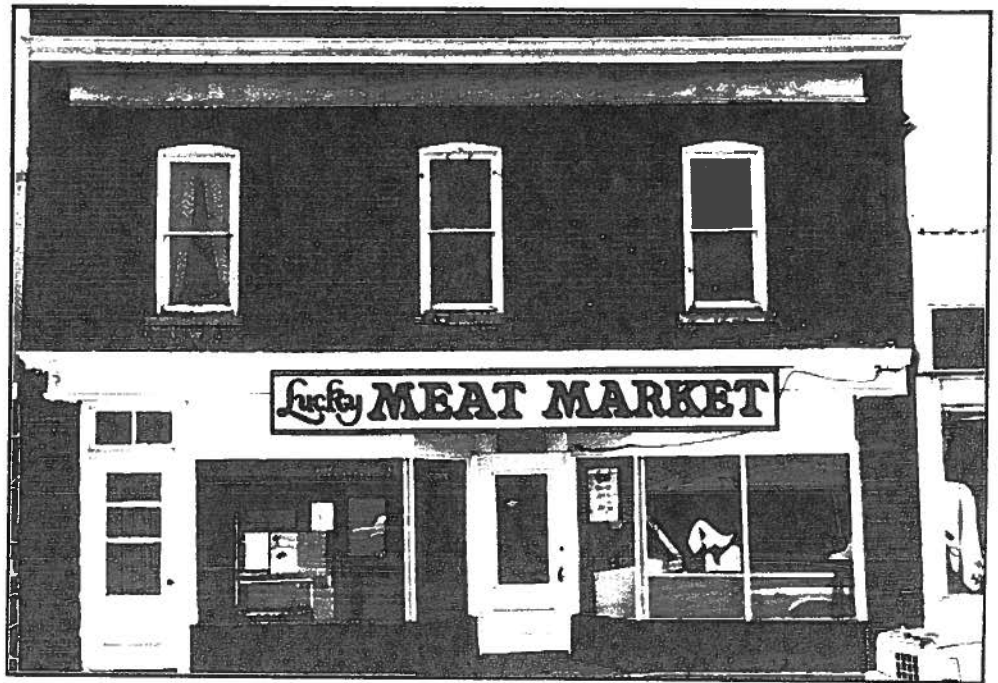
Fig. 62
The doorways Lucky Meats Building
1990

Entrances to upper floors from street level are often from the front of the building, usually to one side. They are treated in a less significant way than the shop entrances, clearly differentiating the public realm from the private.

Preserve and maintain original entrance configuration. Expose, repair and maintain original materials. Where changes have occurred reconstruction of the original configuration is recommended if sufficient documentation exists.

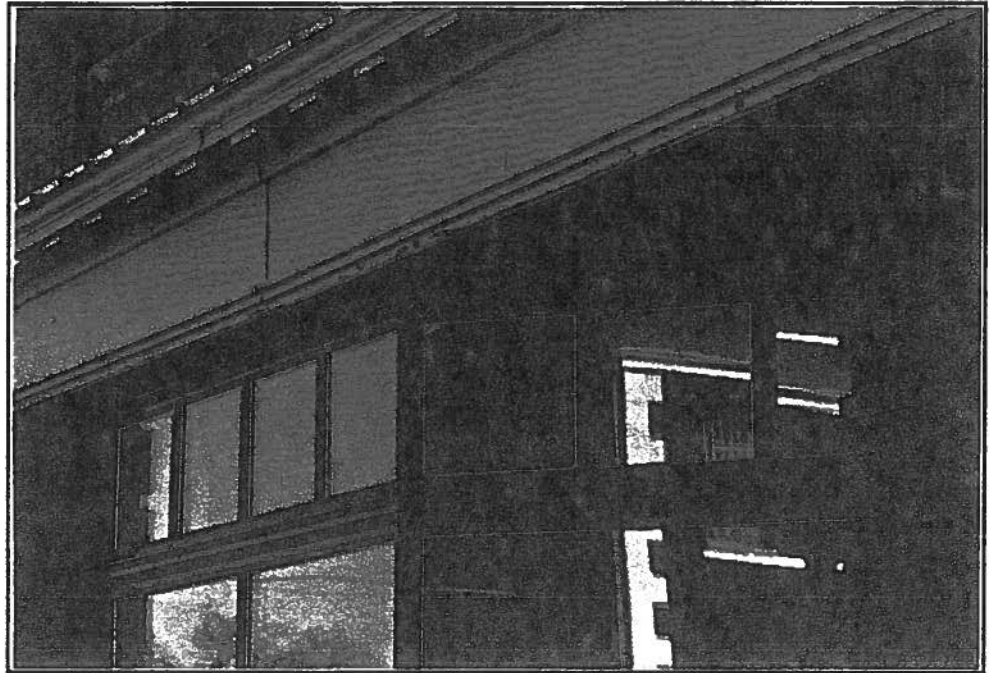
*Fig. 64
Transom windows in the restored
Milnes Block 1990*

Transom glazing was commonly located over the ground floor display windows. The purpose was to allow natural light to penetrate deeply into the store.

Preserve and maintain original transom glazing where possible. Replacement windows should be identical to the original in size and configuration. When a window(s) must be blocked out, maintain the original configuration detail.

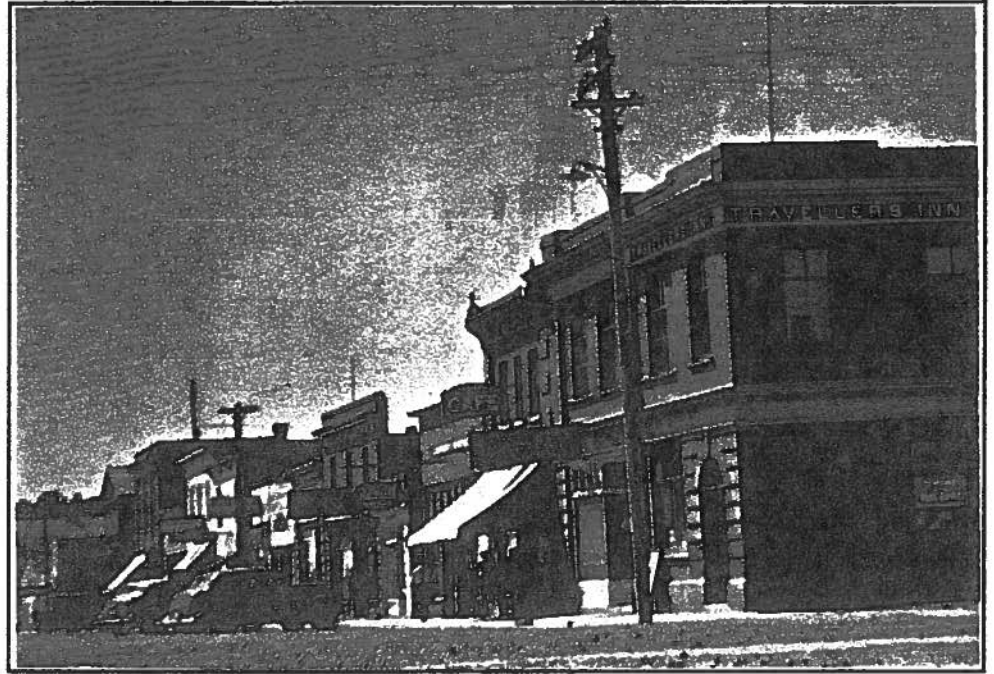
*Fig. 66
Traditional profile awnings on the
historic Kountry Kitchen Building*

Traditional profile, fixed or retractable awnings with a skirt and utilizing high quality canvas or acrylic, solid or striped material, are recommended to enhance the historic character of the Main Street area.

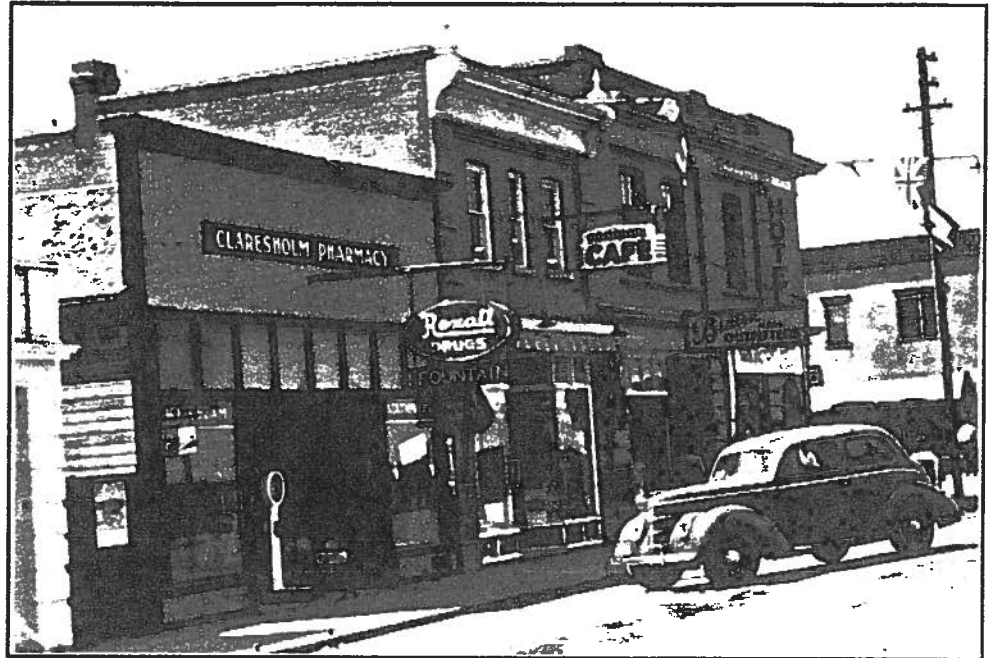
Fig. 70
Projecting signage on the historic
Claresholm Pharmacy and Claresholm
Cafe circa 1945

Other forms of signage included painted lettering on display and upper windows. Large painted wall signs were a common method of long range advertising of merchandise as were neon signs.

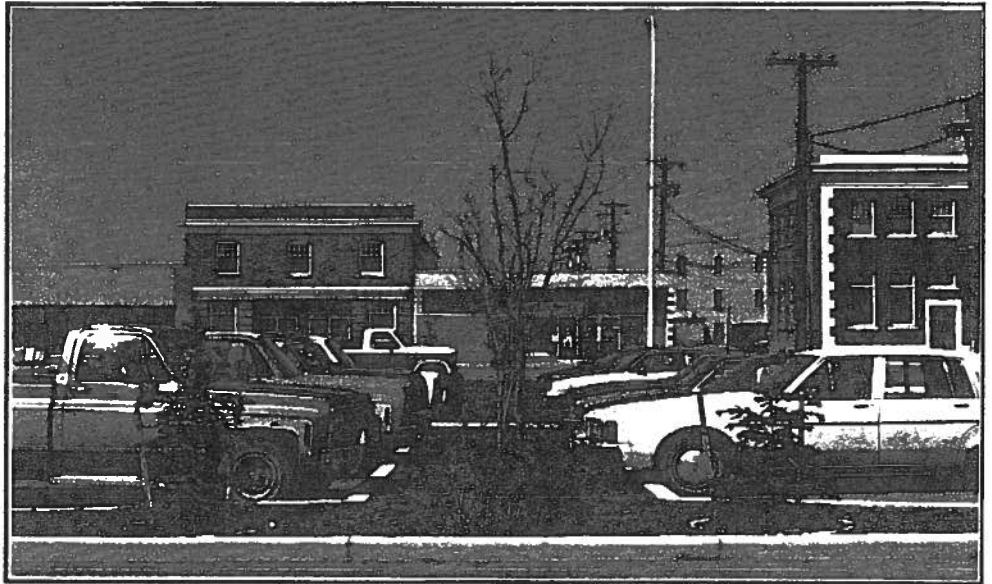
Fig. 83
Claresholm's new downtown parking lot is framed and defined by tree plantings.

- **Parking lots shall be clearly defined or framed by vegetation (ie. trees or shrubs).**

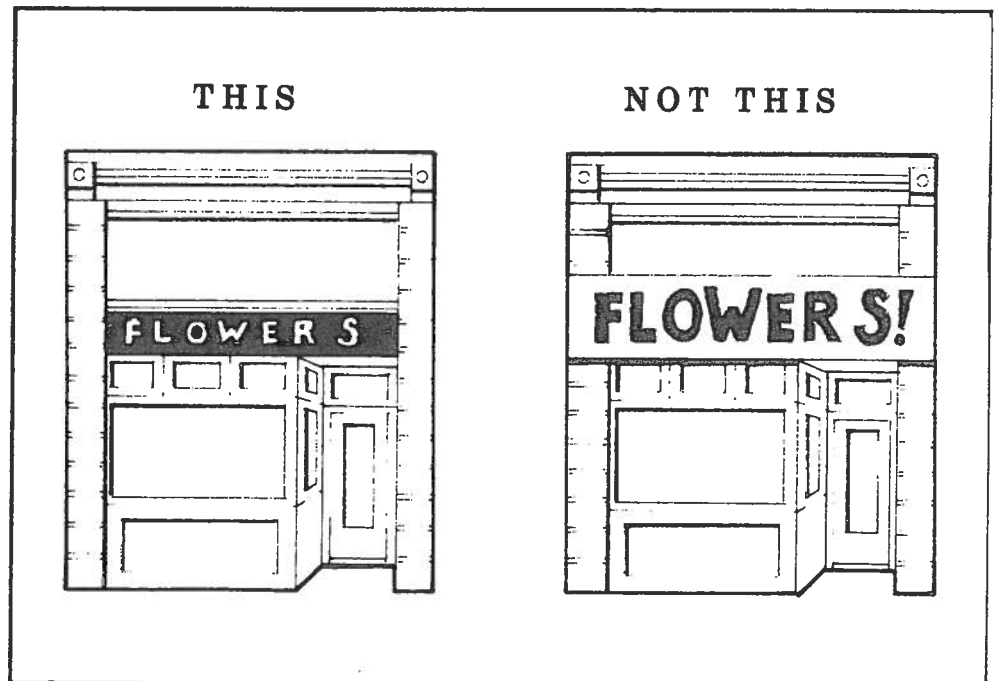
Fig. 87
Correct mounting of internally
illuminated fascia sign between piers
