# GREENWOOD ESTATES AREA STRUCTURE PLAN

LOT 1 BLOCK 15 PLAN 0614136  
IN  
SW 1/4 - 21 - 9 - 22 - 4  
IN  
TOWN OF COALHURST

**Prepared by: MARTIN GEOMATIC CONSULTANTS LTD.**

**PROJECT 166773CE  
January 2017**

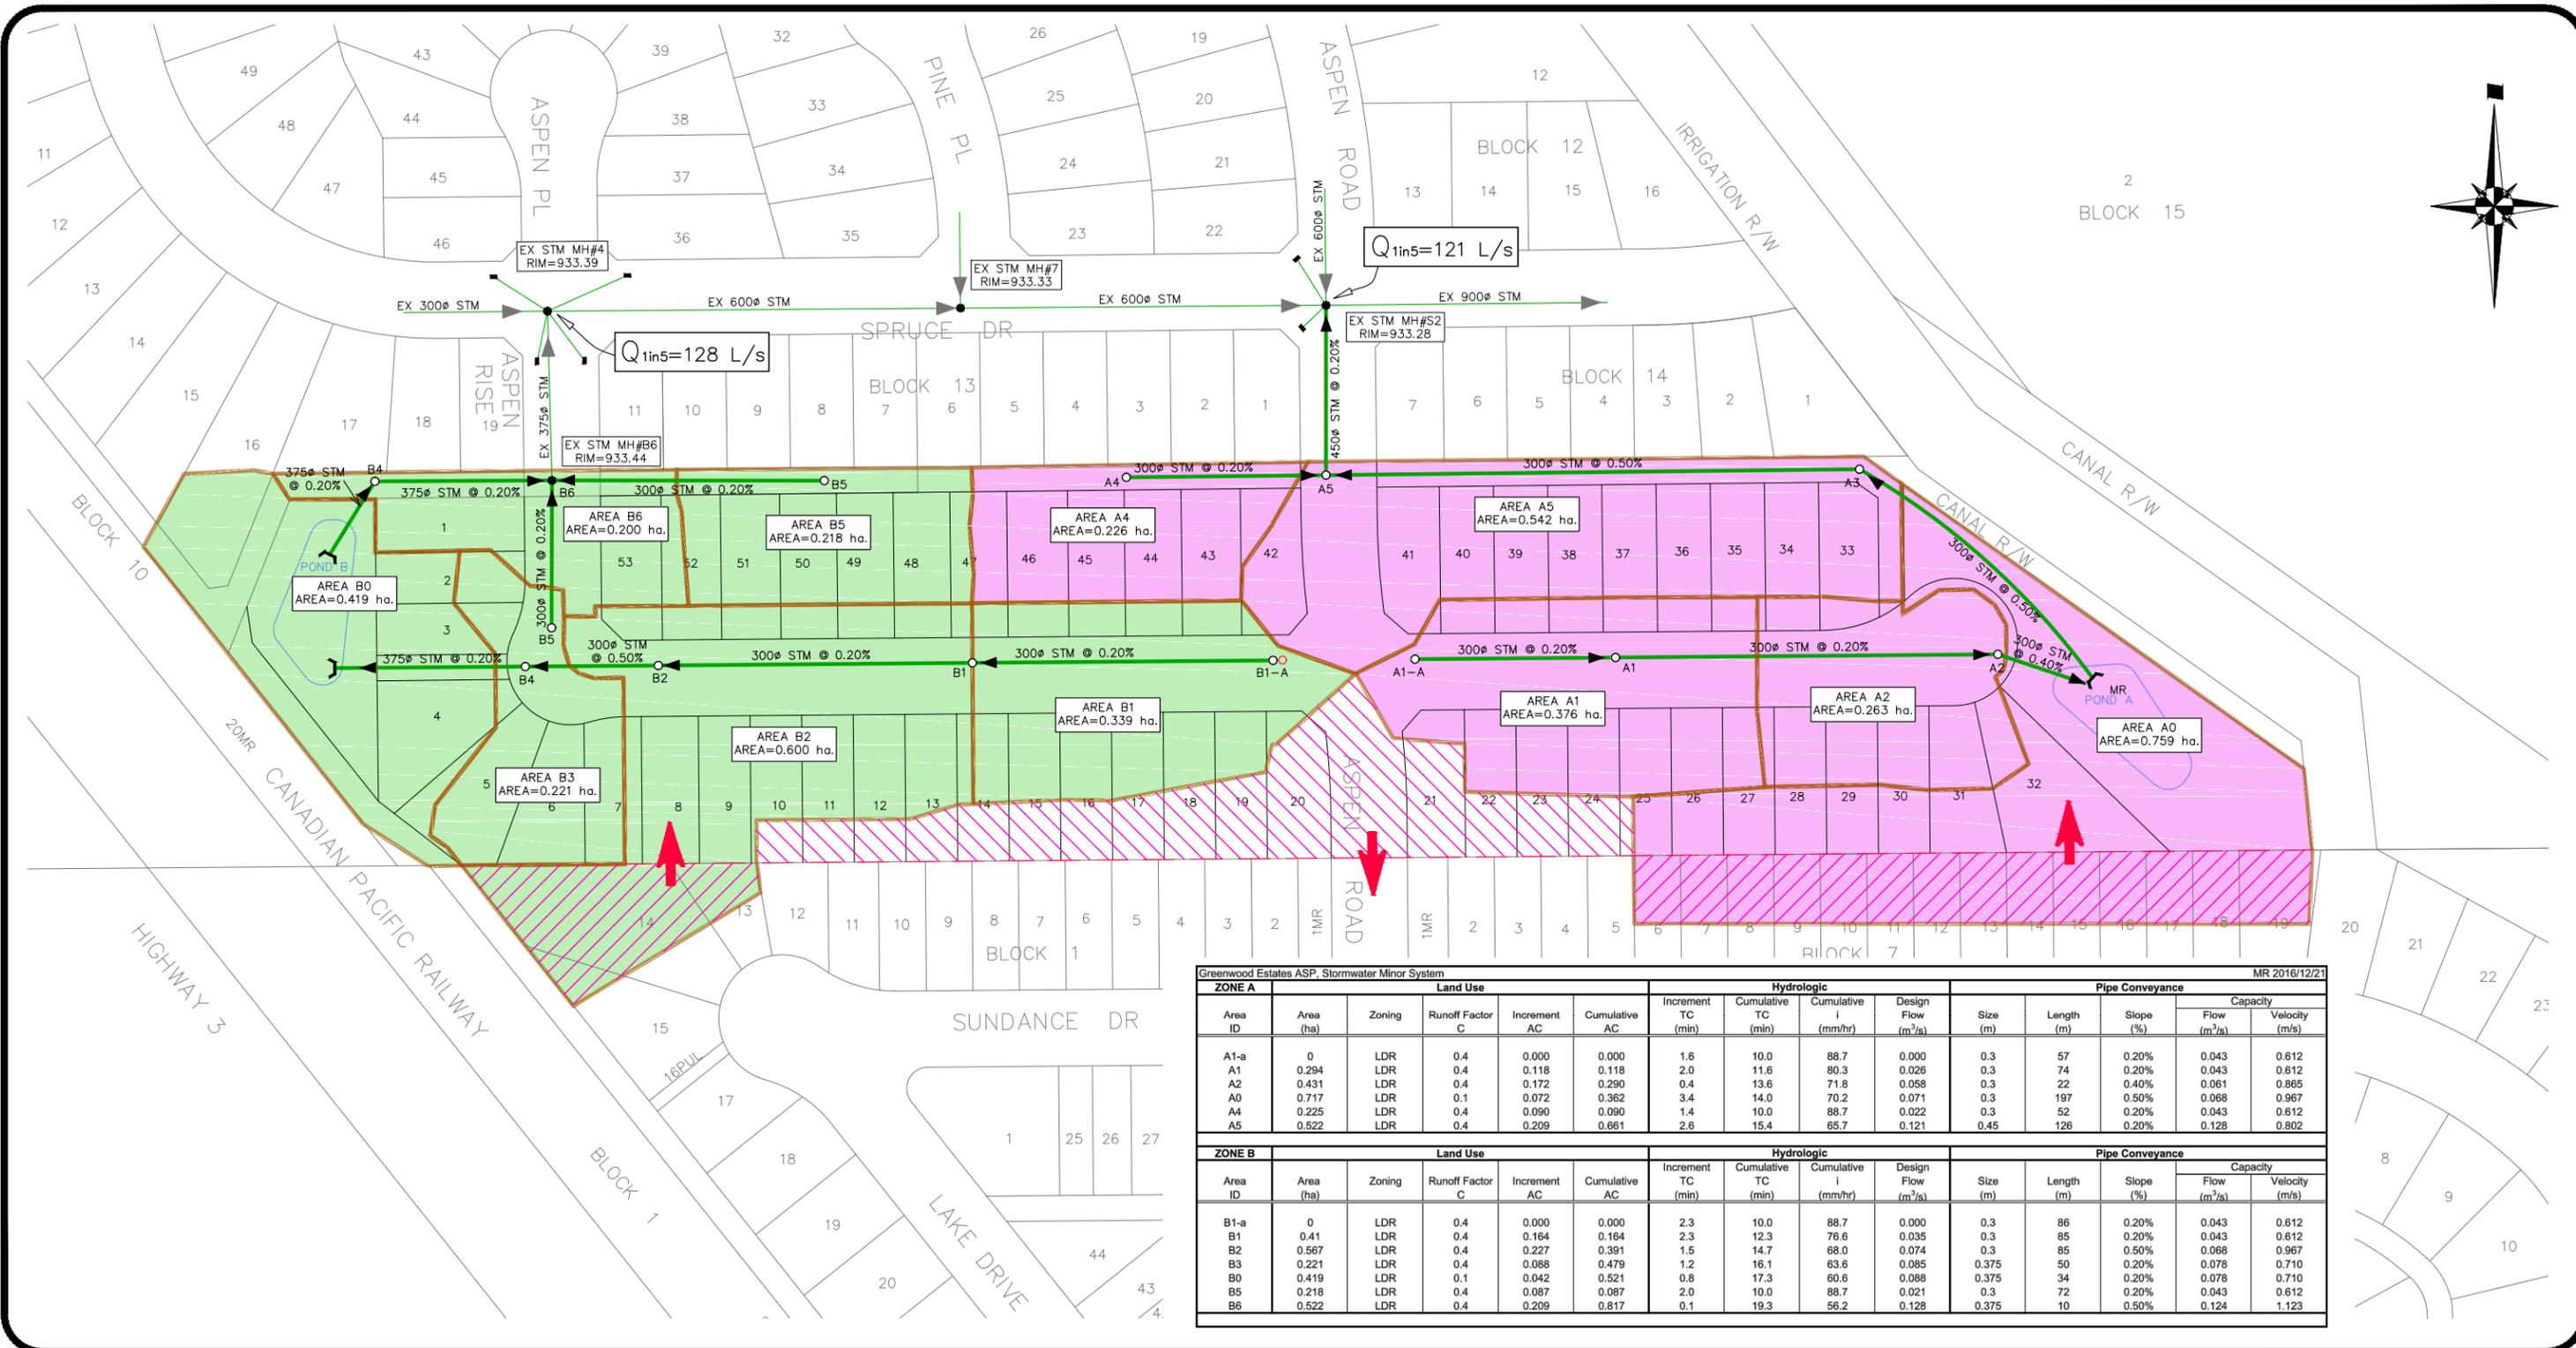
Greenwood Estates ASP. Stormwater Minor System MR 2016/12/21

ZONE A						Hydrologic				Pipe Conveyance				
Area ID	Area (ha)	Zoning	Runoff Factor C	Increment AC	Cumulative AC	Increment TC (min)	Cumulative TC (min)	Cumulative i (mm/hr)	Design Flow (m <sup>3</sup> /s)	Size (m)	Length (m)	Slope (%)	Flow (m <sup>3</sup> /s)	Capacity Velocity (m/s)
A1-a	0	LDR	0.4	0.000	0.000	1.6	10.0	88.7	0.000	0.3	57	0.20%	0.043	0.612
A1	0.294	LDR	0.4	0.118	0.118	2.0	11.6	80.3	0.026	0.3	74	0.20%	0.043	0.612
A2	0.431	LDR	0.4	0.172	0.290	0.4	13.6	71.8	0.058	0.3	22	0.40%	0.061	0.865
A0	0.717	LDR	0.1	0.072	0.362	3.4	14.0	70.2	0.071	0.3	197	0.50%	0.068	0.967
A4	0.225	LDR	0.4	0.090	0.090	1.4	10.0	88.7	0.022	0.3	52	0.20%	0.043	0.612
A5	0.522	LDR	0.4	0.209	0.661	2.6	15.4	65.7	0.121	0.45	126	0.20%	0.128	0.802

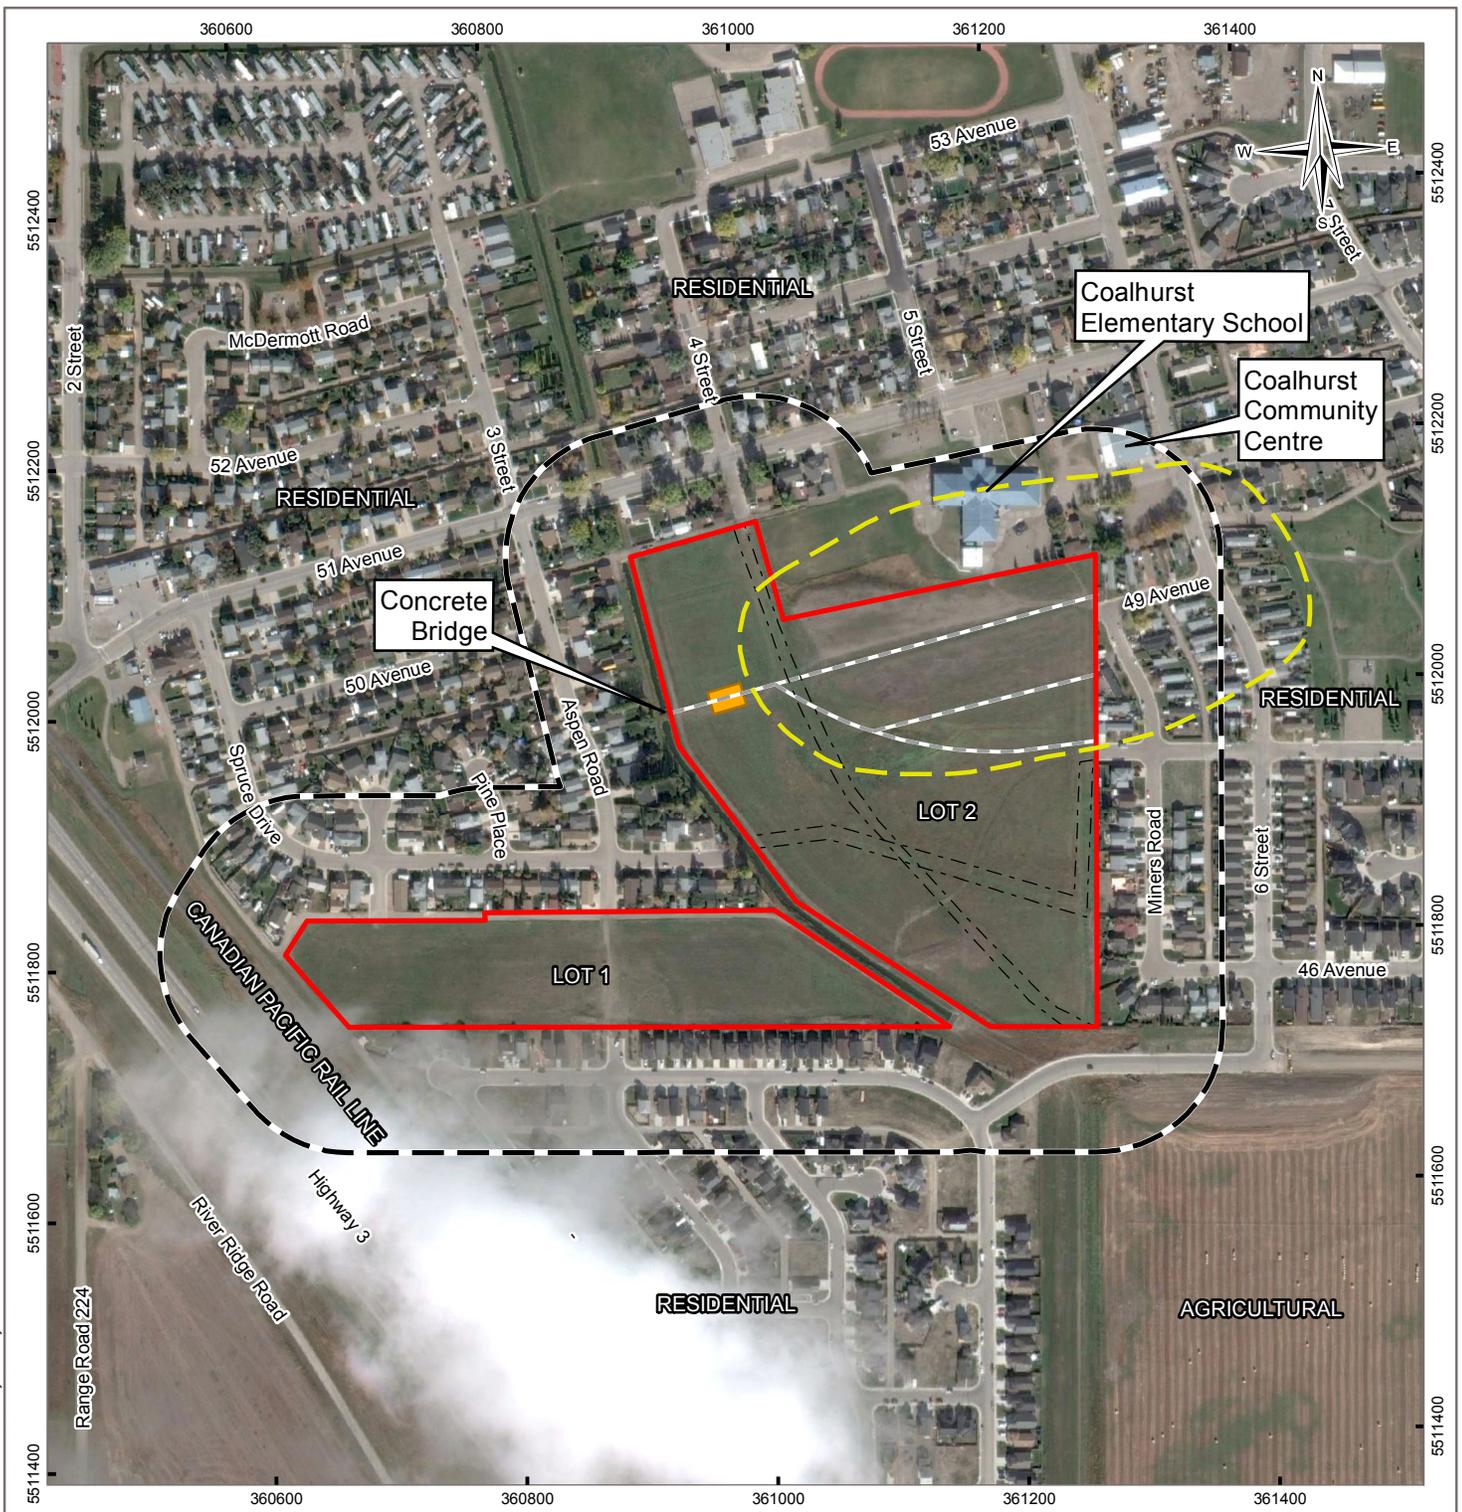
<b>PROJECTION</b> UTM Zone 12	<b>DATUM</b> NAD83	<b>CLIENT</b> <b>Town of Coalhurst</b>
Scale: 1:6,000 		
<b>FILE NO.</b> CENV03051_FIG2.mxd		
<b>PROJECT NO.</b> CENV03051-01	<b>DWN</b> BB	<b>CKD</b> MS
<b>OFFICE</b> T1 EBA-CAL	<b>APVD</b> BC	<b>REV</b> 0
<b>DATE</b> January 2016		<b>Figure 2</b>

- Approximate Location of Former Rail Spur
- Approximate Location of Concrete Foundation
- Approximate Location of Coal Waste
- Site Boundary
- Utility Right of Way
- 100m Search Radius

There are currently no buildings on the site. Historically, a scale house associated with the former coal mine activities would have been located on the northern portion of Lot 2. During the site visit, portions of a concrete foundation were encountered that may be associated with this former building.

- It is noted that a rail line may have transected the most western portion of Lot 1, however, the overlay of the 1918 insurance plan on to the current day site plan may be skewed and this rail line may have been further west of the site.

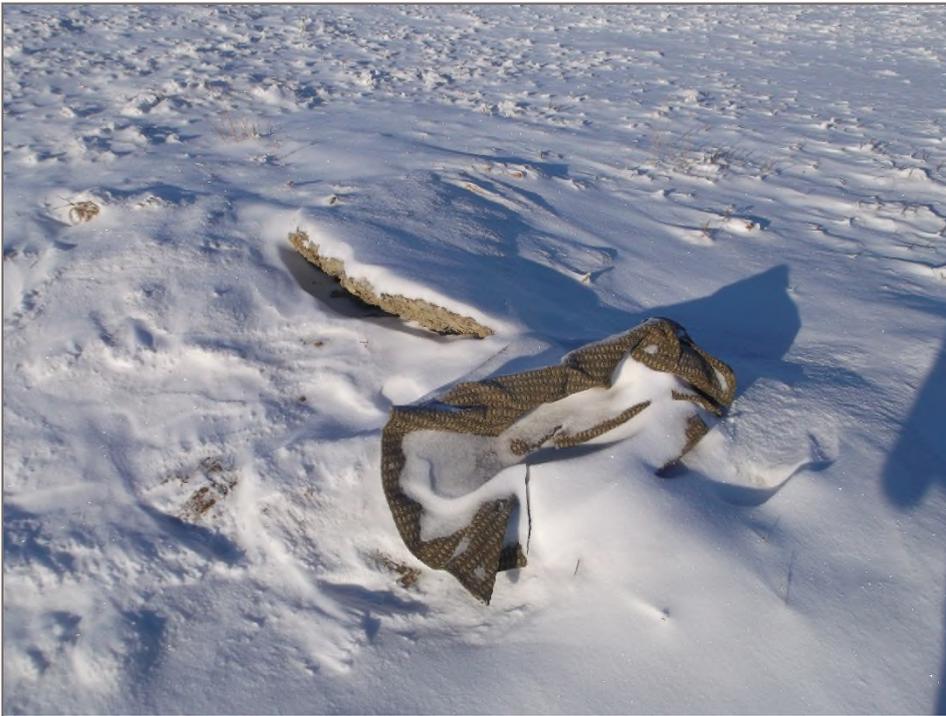
**Photo 4:** Debris identified at Lot 1.

The general housekeeping of Lot 1 and Lot 2 could be improved as there was evidence of illegal dumping observed during the site visit. Concrete, wood, and steel debris was observed at each Lot at the time of the site visit.

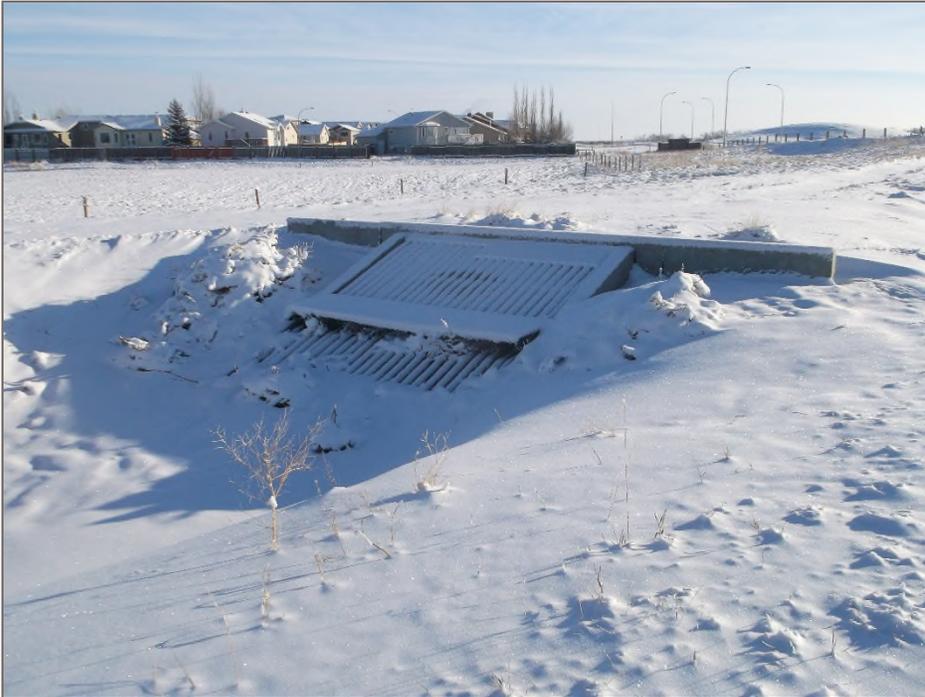
**Photo 7:** View of irrigation canal infrastructure near southern boundary of Lot 1.

There was no evidence of ponded water observed on the site during the site visit. The irrigation canal that bi-sects Lot 1 and Lot 2 is expected to contain water during warmer months.

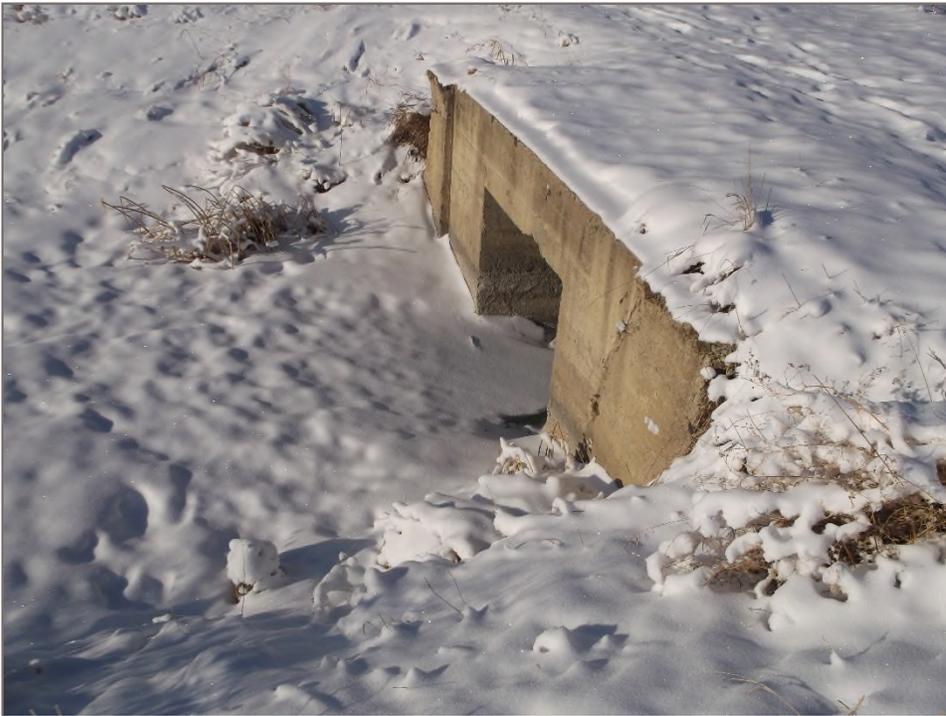
**Photo 10:** View of concrete structure (bridge) over the irrigation canal, located at the western boundary of Lot 2.

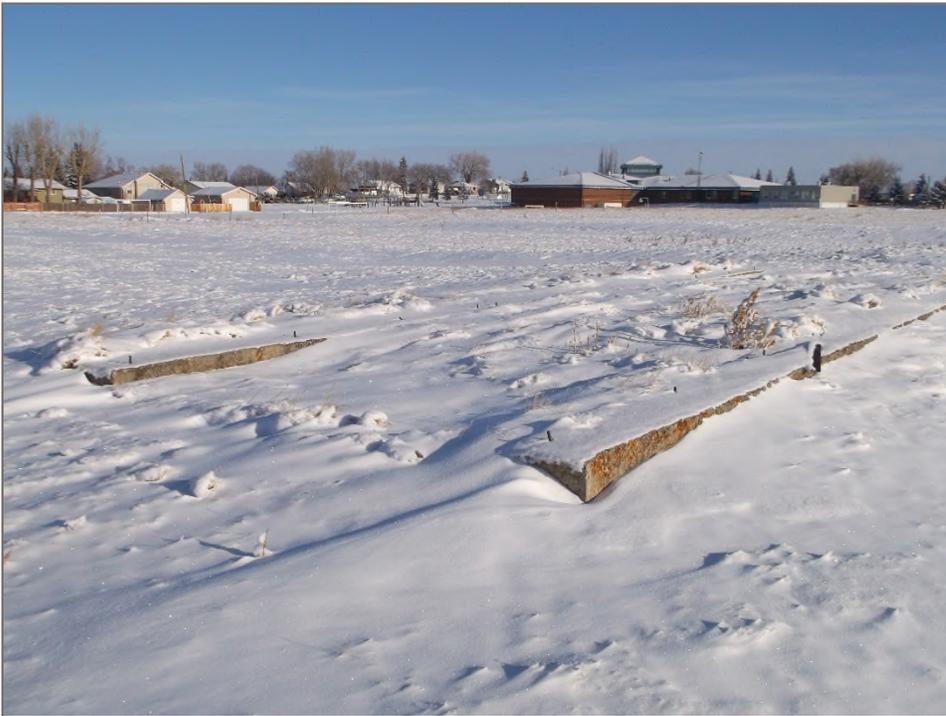
**Photo 12:** View facing east toward concrete foundation located on the western portion of Lot 2.

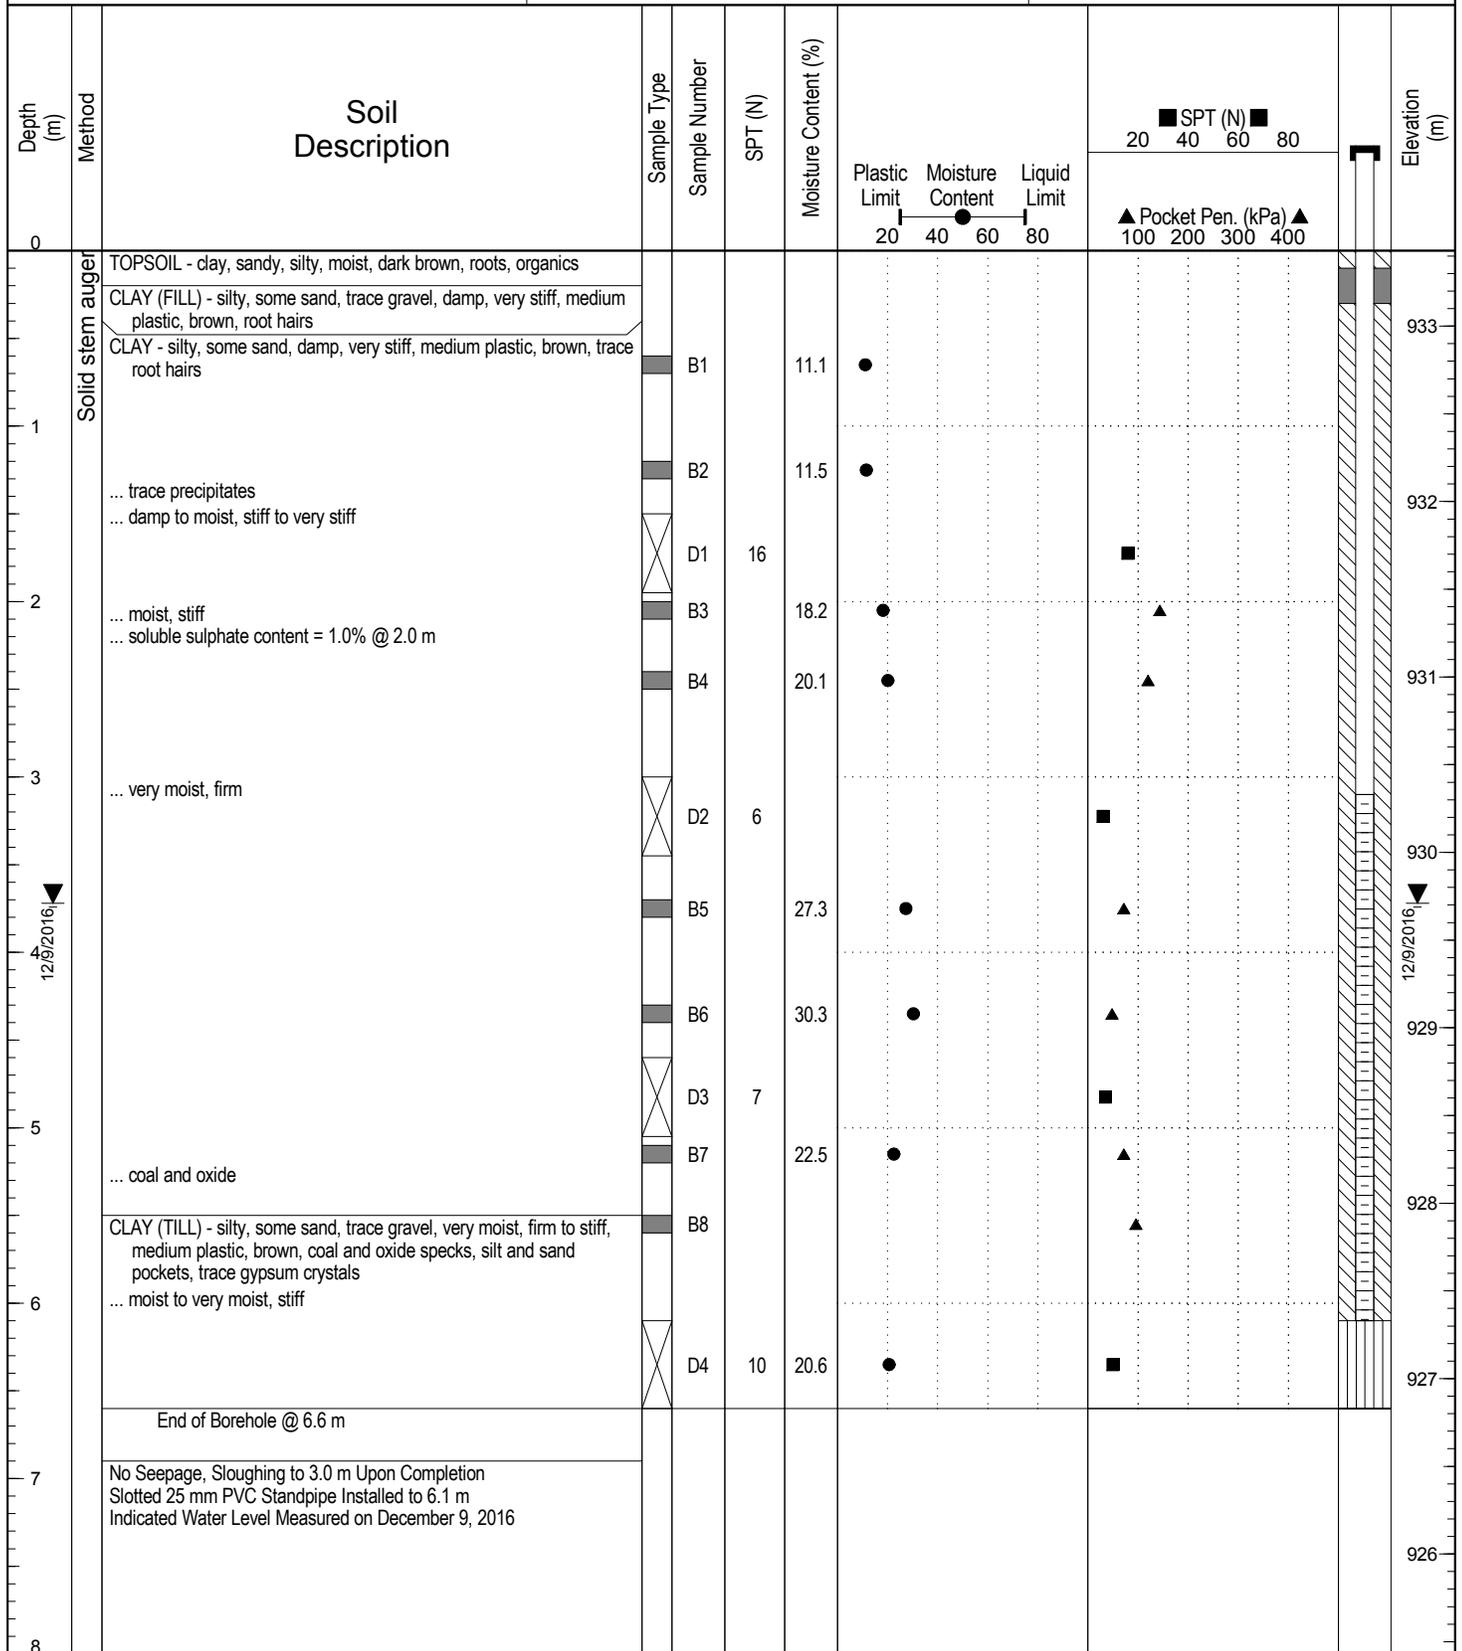
Contractor: CHILAKO DRILLING SERVICES LTD.

Completion Depth: 6.6 m

- iii. A Geotechnical Evaluation was completed by Tetra Tech EBA (TT) and is included in the Appendix. Three boreholes were drilled on-site to depths of 6.1 to 6.6 meters, which found topsoil above clay fill, clay, and clay till. Groundwater depths were observed at 3.6 to 3.7 meters.

- iv. Groundwater was observed at depths of 3.6 to 3.7 meters below the surface (elevations 929.7m to 929.9m) at the time of borehole drilling. Ground water was not observed at one location to a depth of 6.6m (refer to the attached Appendix).

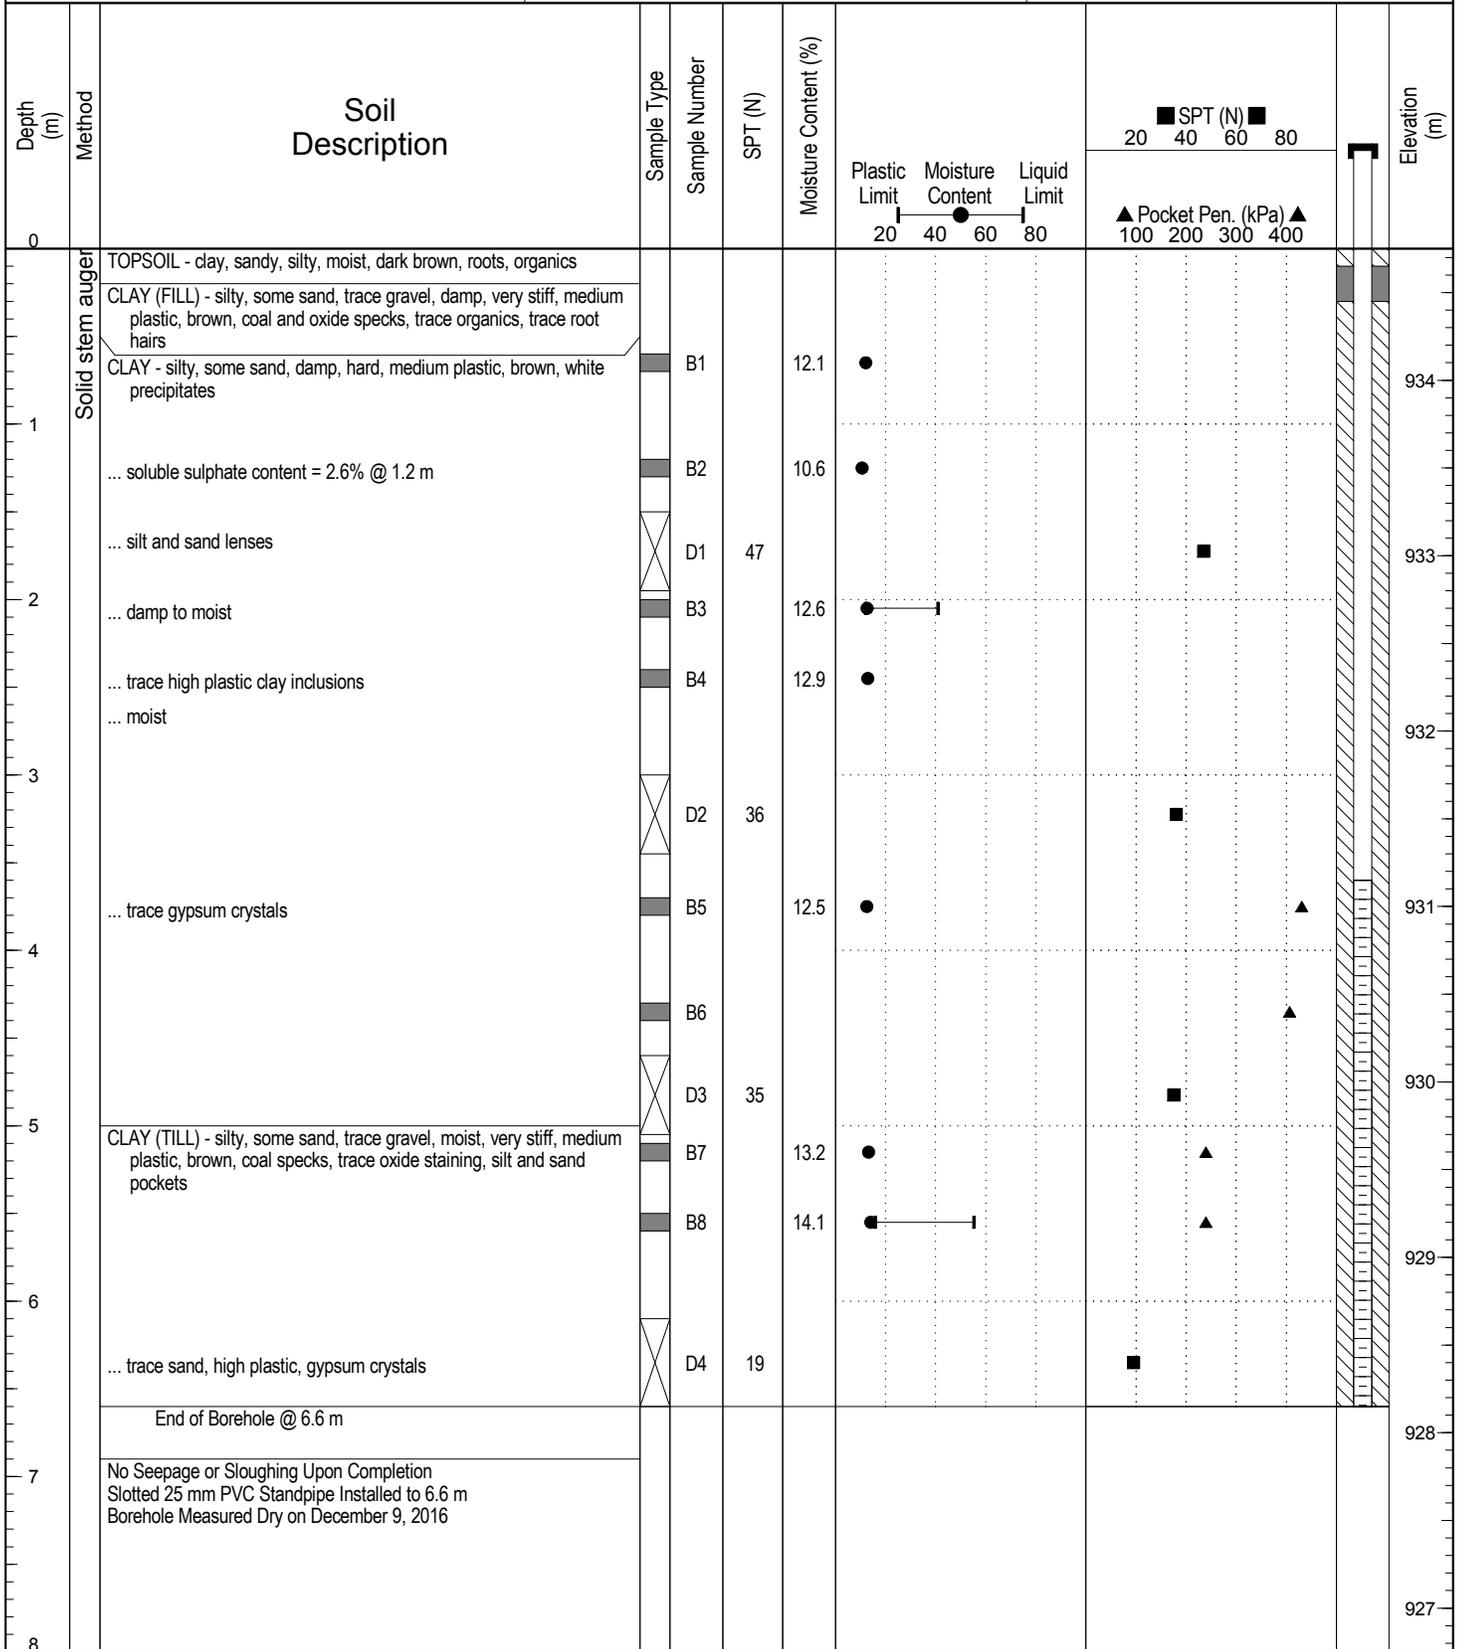
Contractor: CHILAKO DRILLING SERVICES LTD.

Completion Depth: 6.6 m

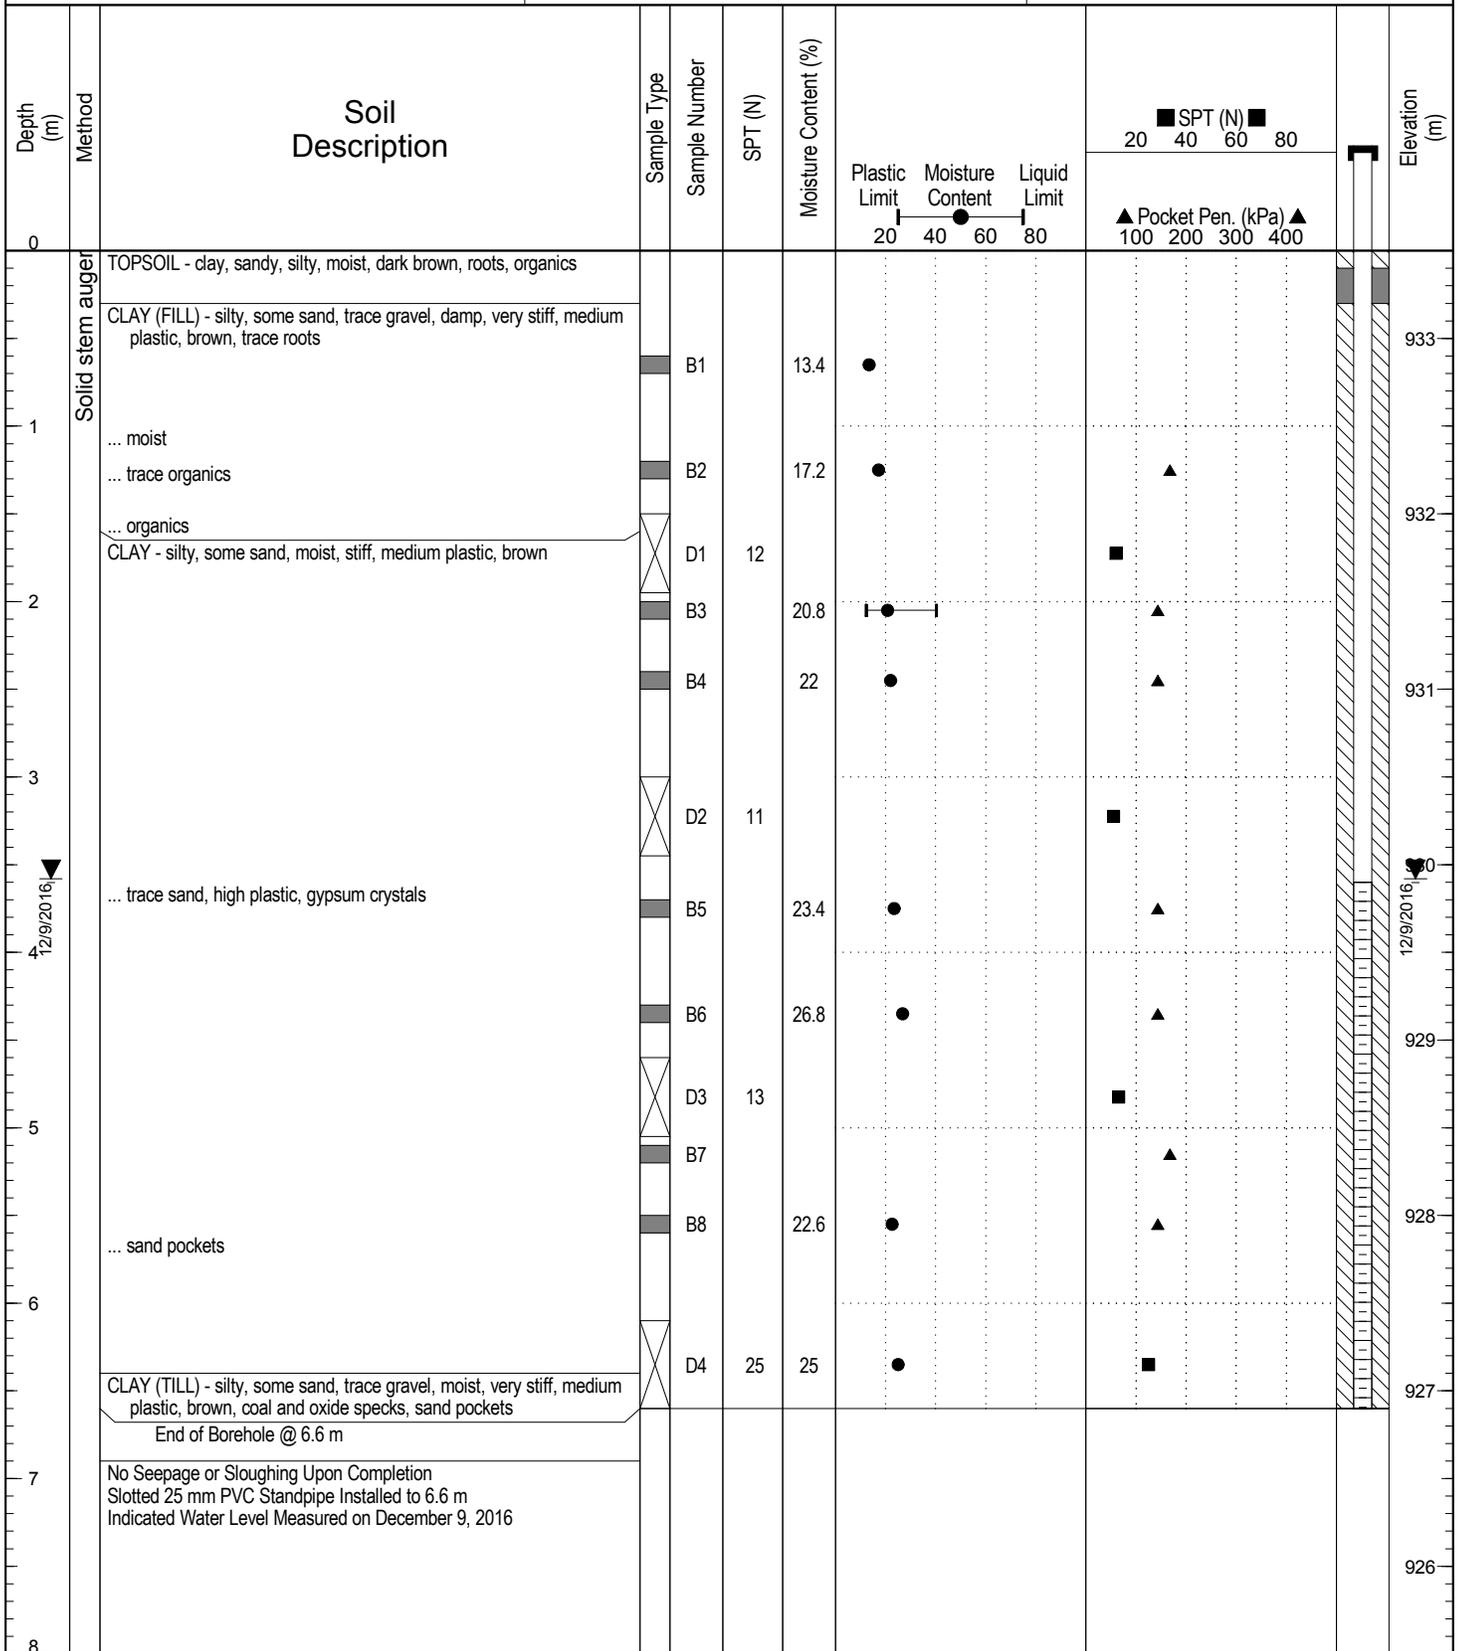
Contractor: CHILAKO DRILLING SERVICES LTD.

Completion Depth: 6.6 m
