butte landing

AREA STRUCTURE PLAN

TITLE Butte Landing Area Structure Plan

BYLAW NO. 942-24

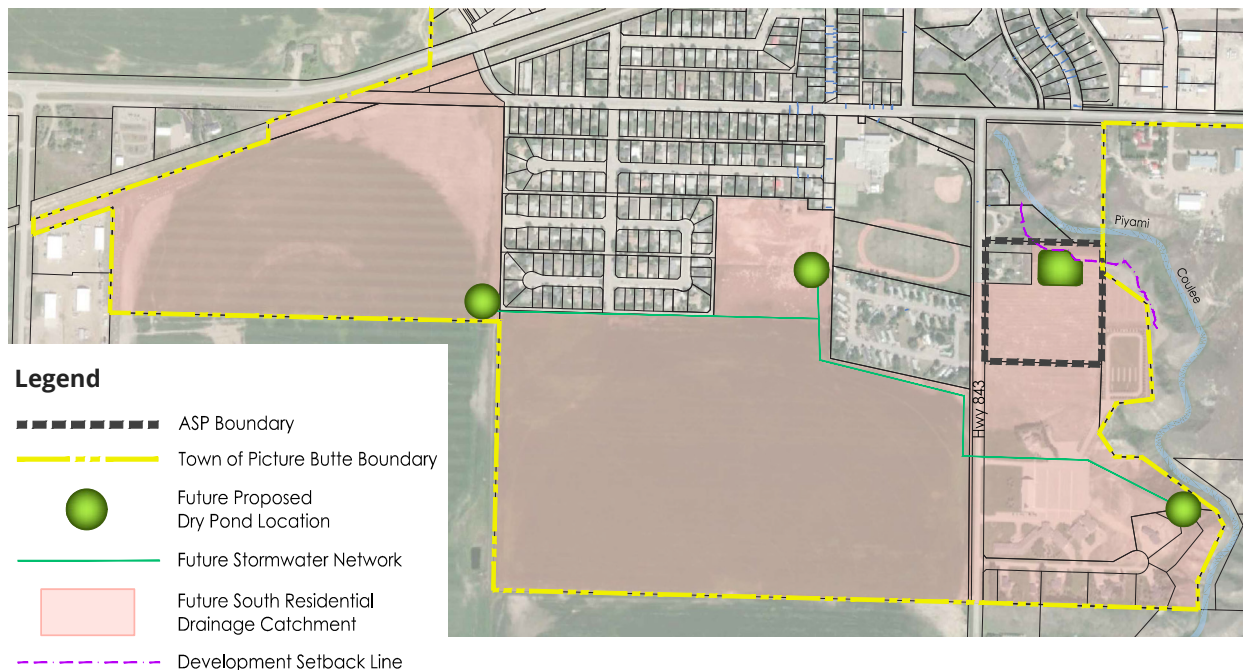
Map 10 South Residential Drainage Strategy

Regardless of the outfall option that is chosen for the development, Butte Landing will incorporate a stormwater management system that conveys, treats, and attenuates urban development flows to pre-development conditions using a minor storm sewer system and a major storm system that manages surface run-off during extreme rainfall events. All parcel and lot grading plans shall conform with the overall stormwater management plan as required by the Town at the subdivision or development stage.

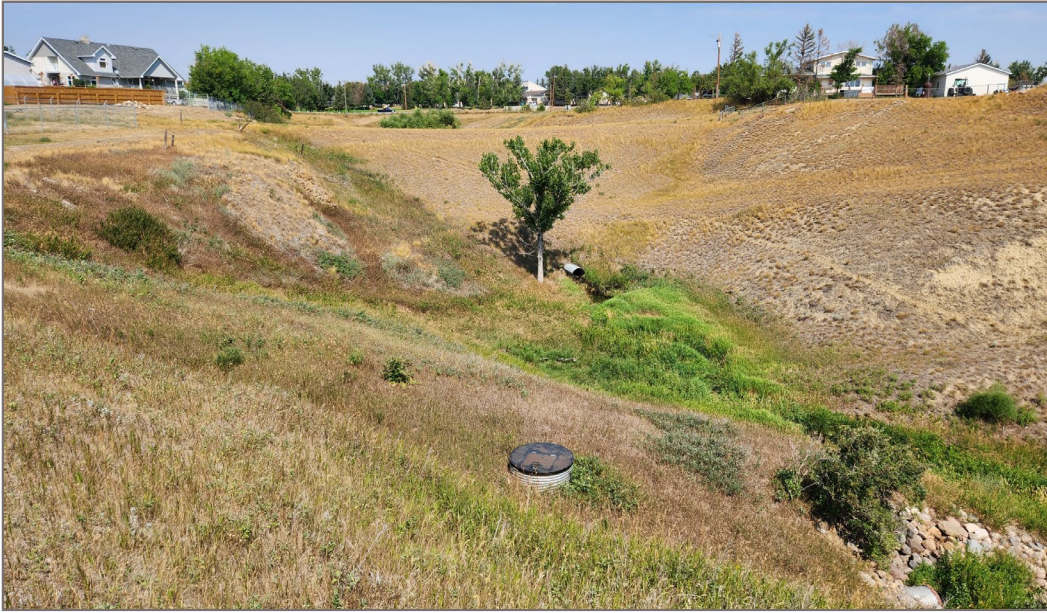
Photo 5: Culvert Upstream of the Tributary Coulee.

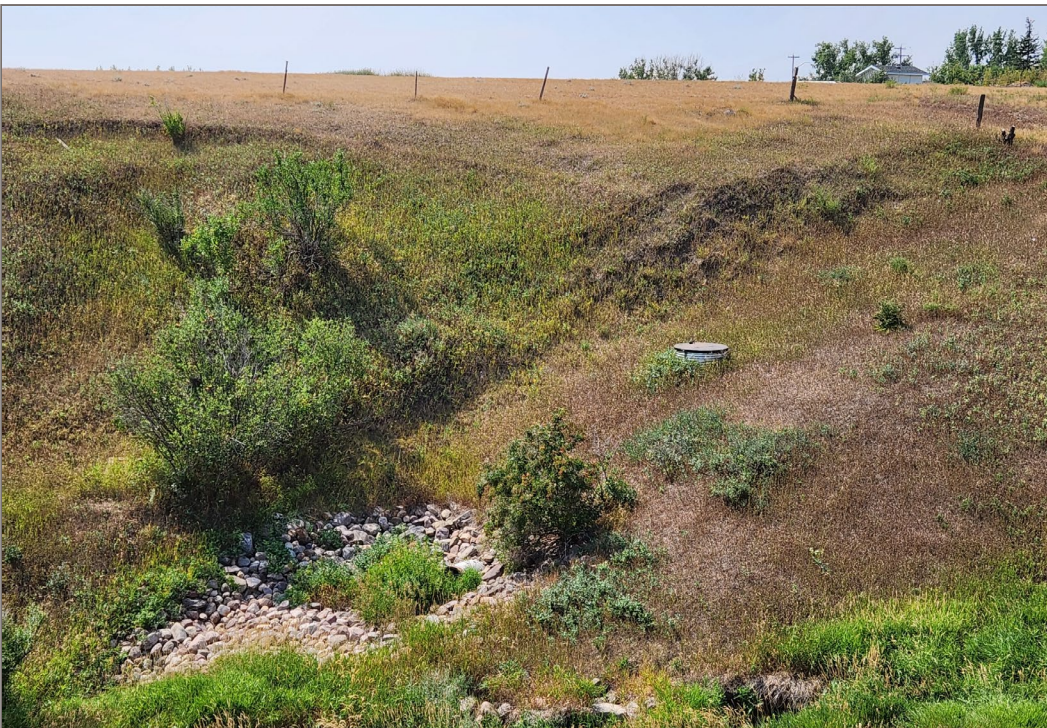
Photo 6: Culvert Along Site Slope.

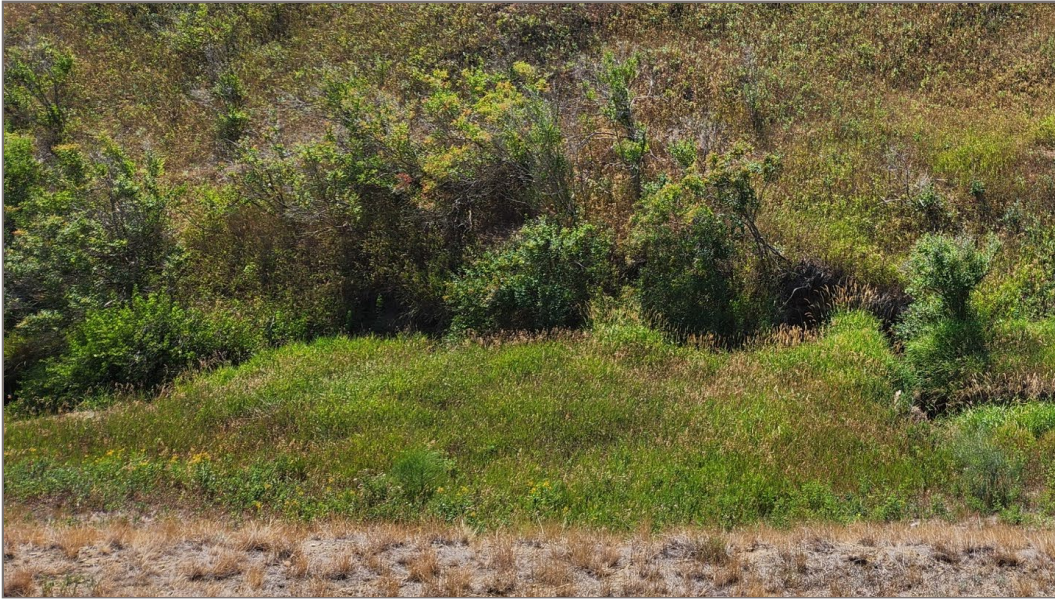
Photo 7: Channel Visible at the Toe of the Site Slope – Facing South Across the Tributary Coulee.

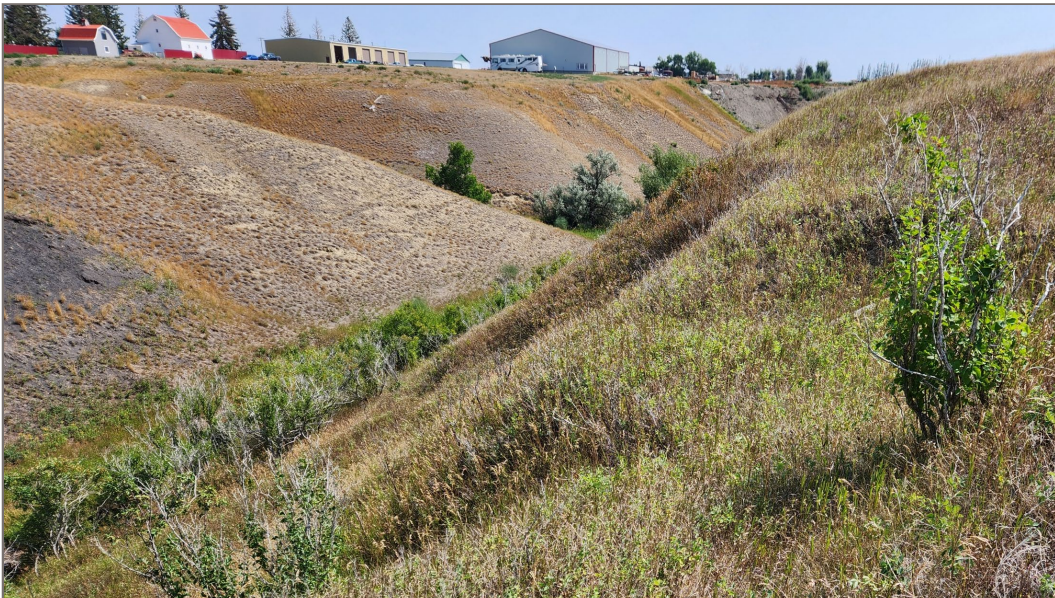
Photo 8: Historical Instability on Slope North of Site – Facing East.

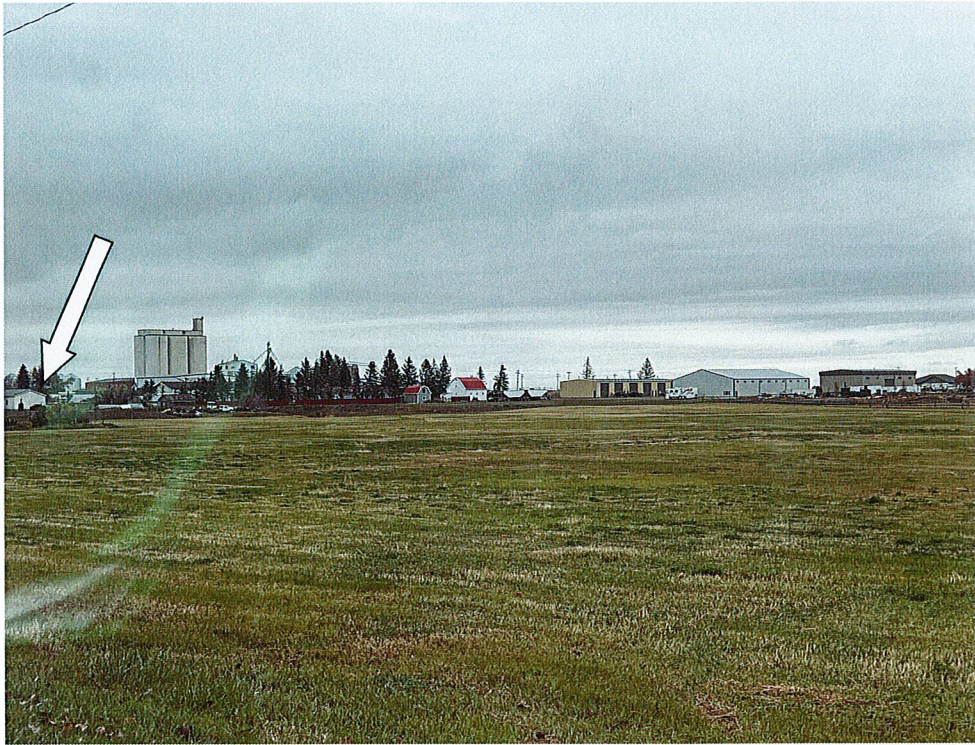
*Photograph 1: Looking northeast at the subject site from Secondary Road 843
Note: Residence located in the northwest corner of the site (arrowed).*

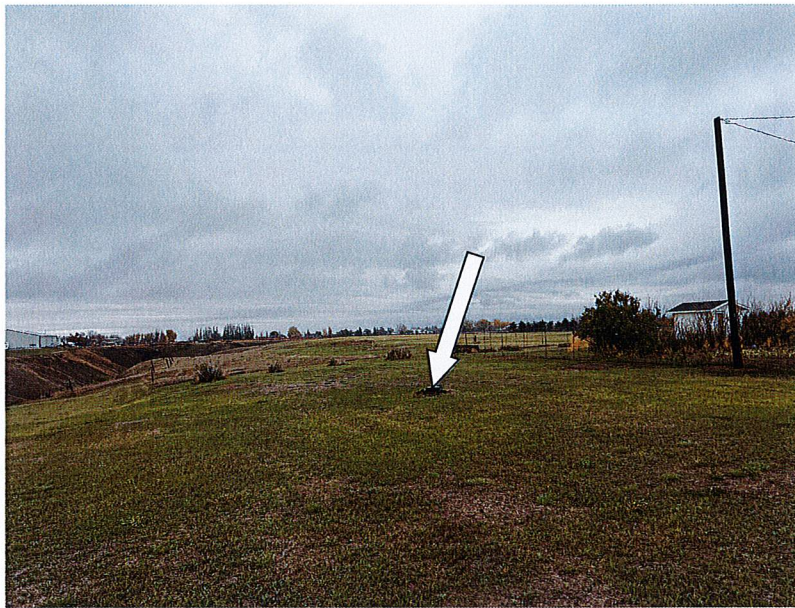
Photograph 2 – Looking east along north property line. Note catch basin Previously installed in preparation for storm sewer connection (arrowed)
